“The New Hydrocarbon Remediation Paradigm”:

Hanby Environmental and OMG Solutions Provide:

Real Time and In-Situ (in place)

Hydrocarbon Contamination

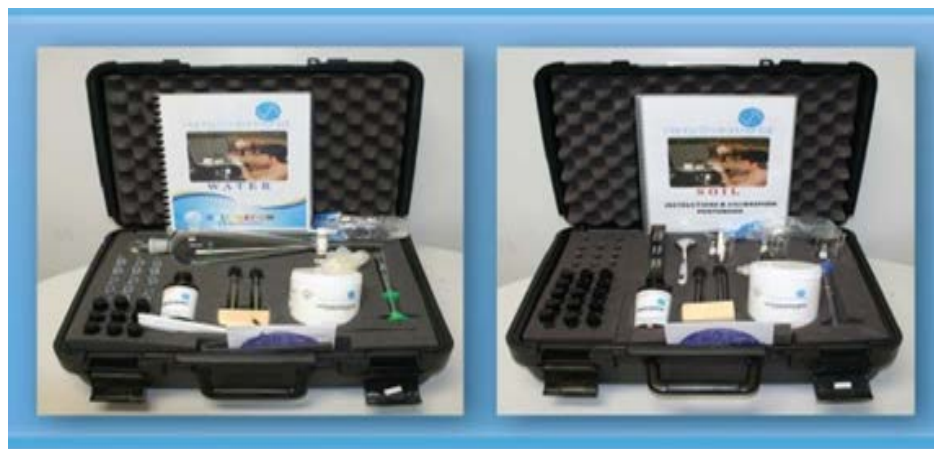
- Self contained kit contains everything to conduct 15 tests including color charts and instructional video.
- Refill sets with 15 tests can be purchased additionally

Kit type		TPH Contamination level
Water		0.1 – 200 PPM
Soil	Low Range	0 – 1000 PPM
	High Range	500 – 50,000 PPM

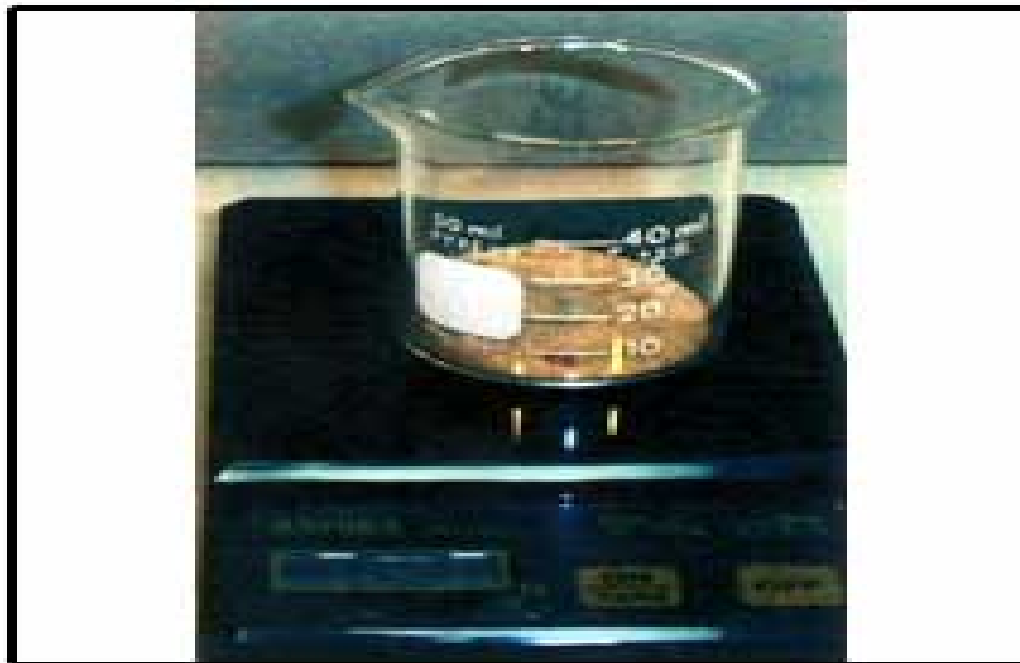
Step 1: Weigh 5 Grams of Soil Sample

1. Weigh sample into tared beaker

1. Weigh sample into tared beaker

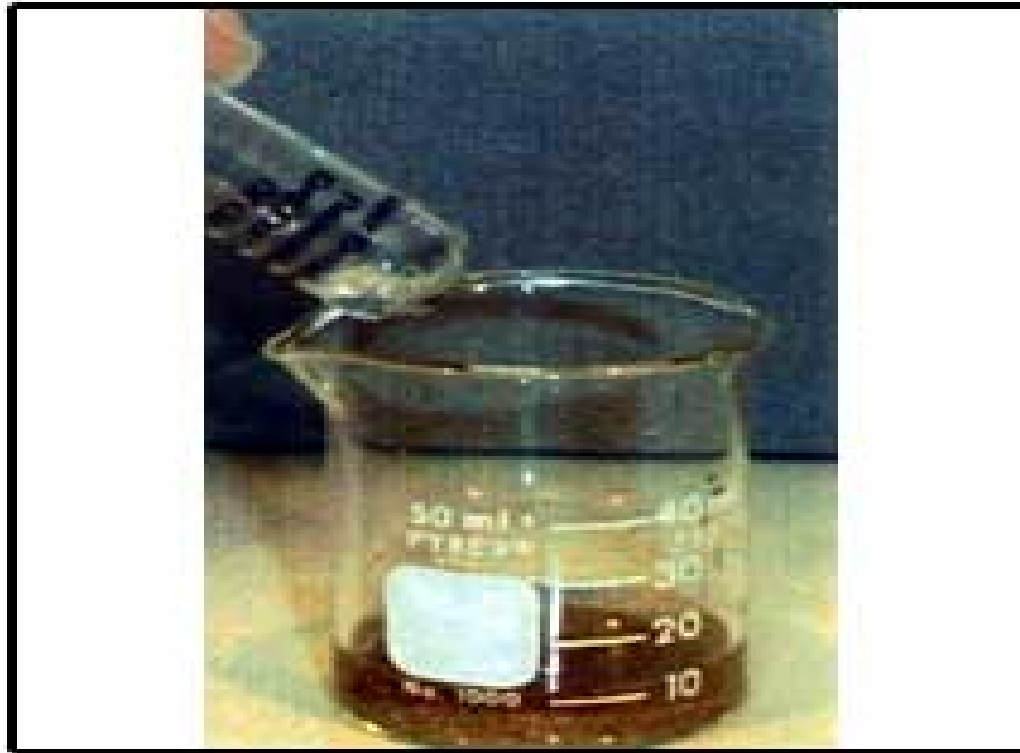
Step 2: *Add Extract Solvent to Sample*

2. Snap ampoule, add solvent

2. Snap ampoule, add solvent

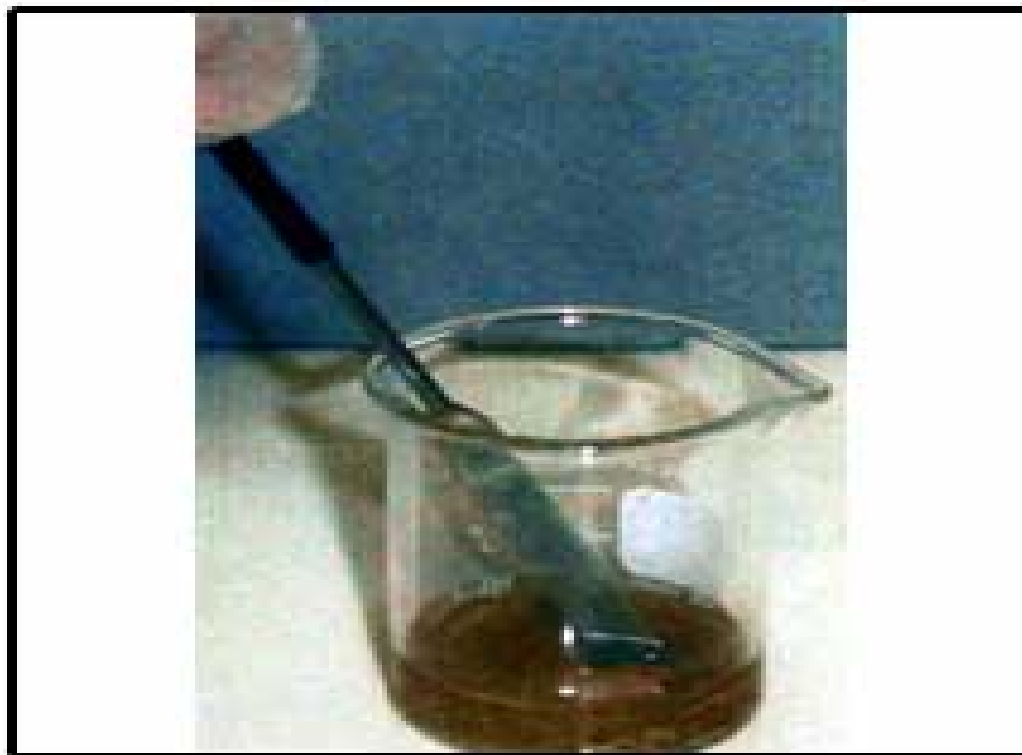
Step 3: *Stir Solvent in Soil Sample*

3. Stir. Mix well

3. Stir. Mix well

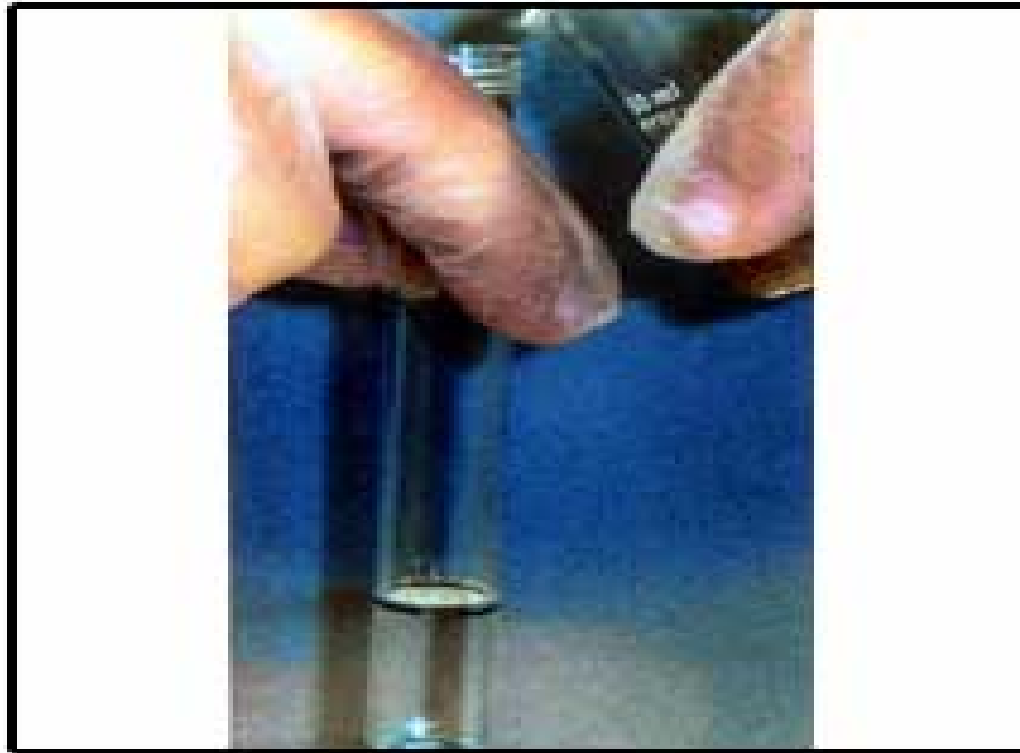
Step 4: *Pour Solvent Into Test Tube*

4. Pour solvent into test tube.

4. Pour solvent into test tube.

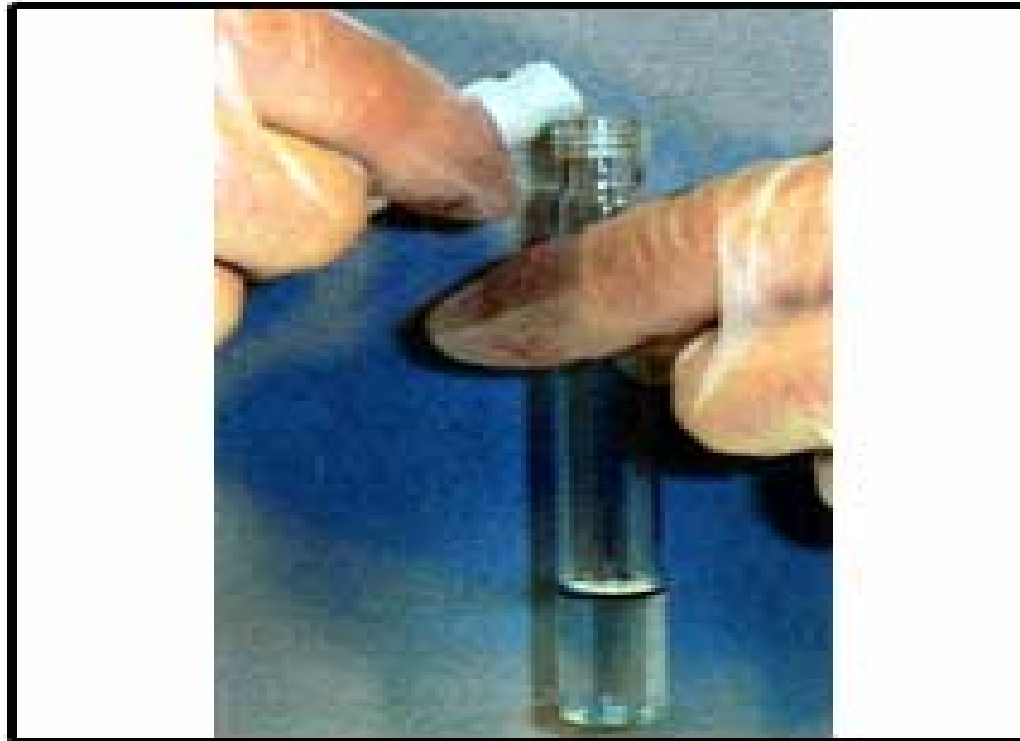
Step 5: *Add Catalyst, Cap and Shake*

5. Add catalyst, cap, shake.

5. Add catalyst, cap, shake.

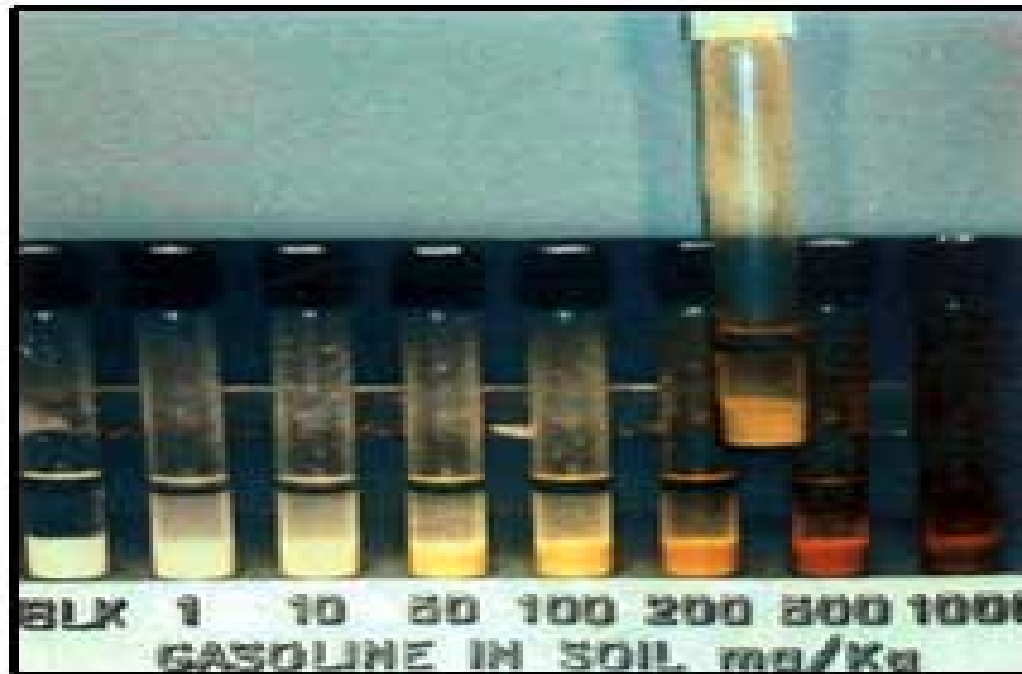
Step 6: *Compare to Standard Photo*

6. Compare with standard photo.

6. Compare with standard photo.

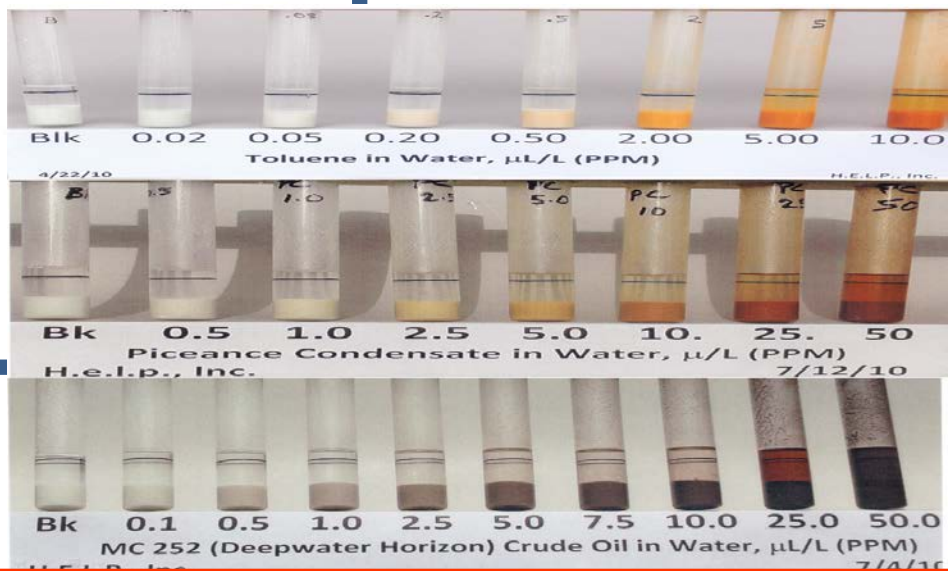
Similar Water Calibration Photos:

Large collection of calibration photos (library)

Hanby Field Test Kit for Petroleum Contaminants in Water, mg/L (PPM)

NOTE 1 - MIXTURE OF AROCLORS 1016, 1232, 1248, 1260.

This chart represents test results of 500 ml. samples of water containing the labeled amounts of contaminant.

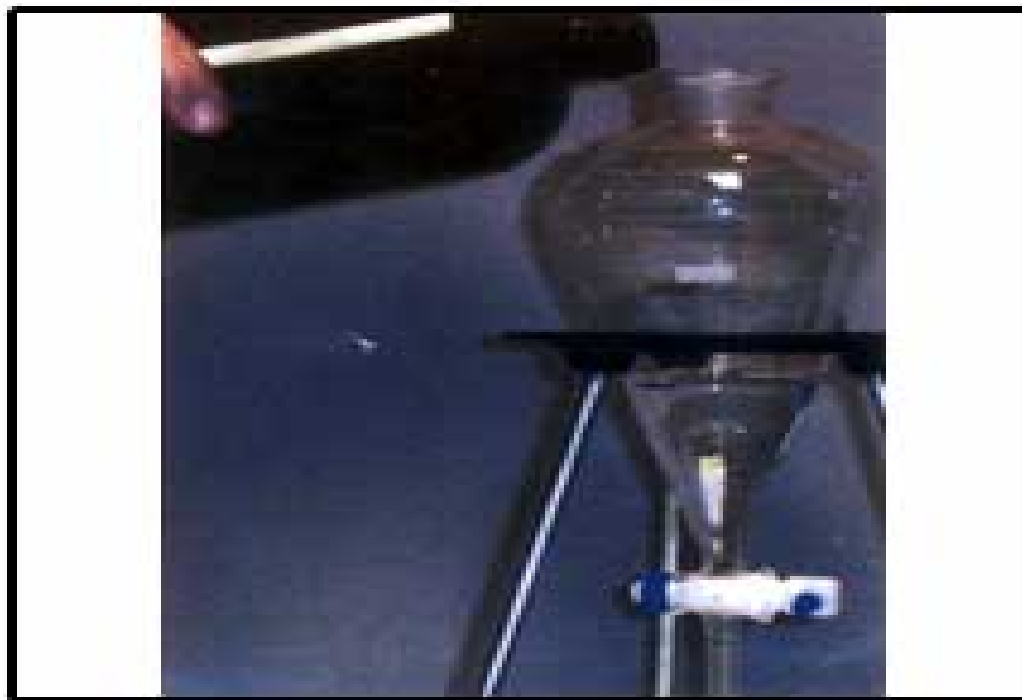
Step 1: *Pour Water Sample Into Sep Funnel*

- 1. Pour water sample into separatory funnel.**

1. Pour water sample into separatory funnel.

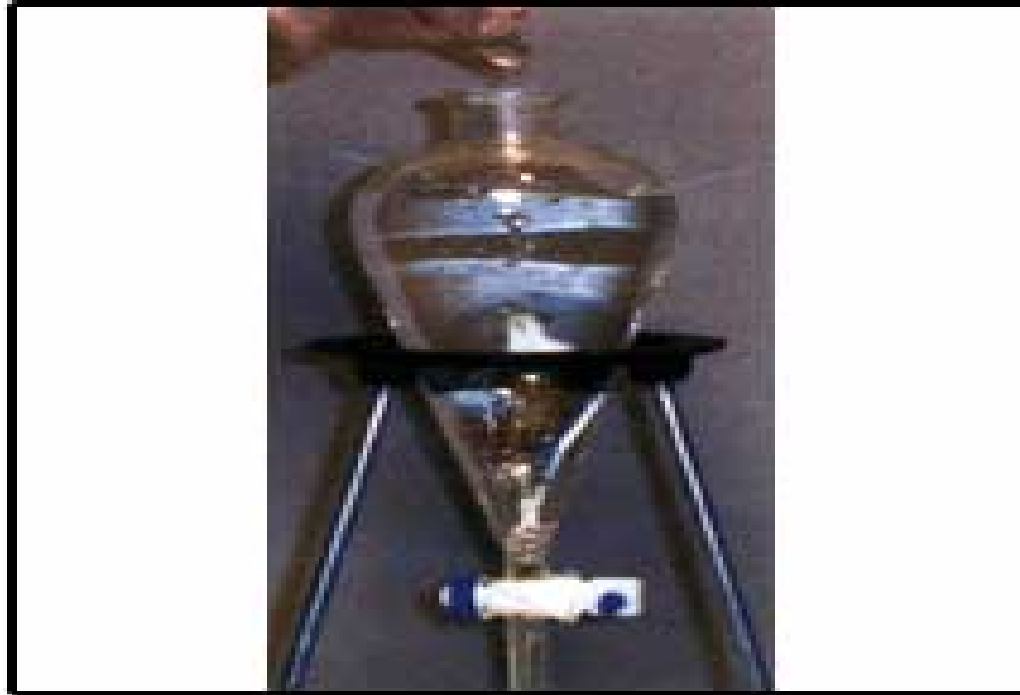
Step 2: *Add Extract Solvent to Sample*

2. Pour solvent in sample.

2. Pour solvent in sample.

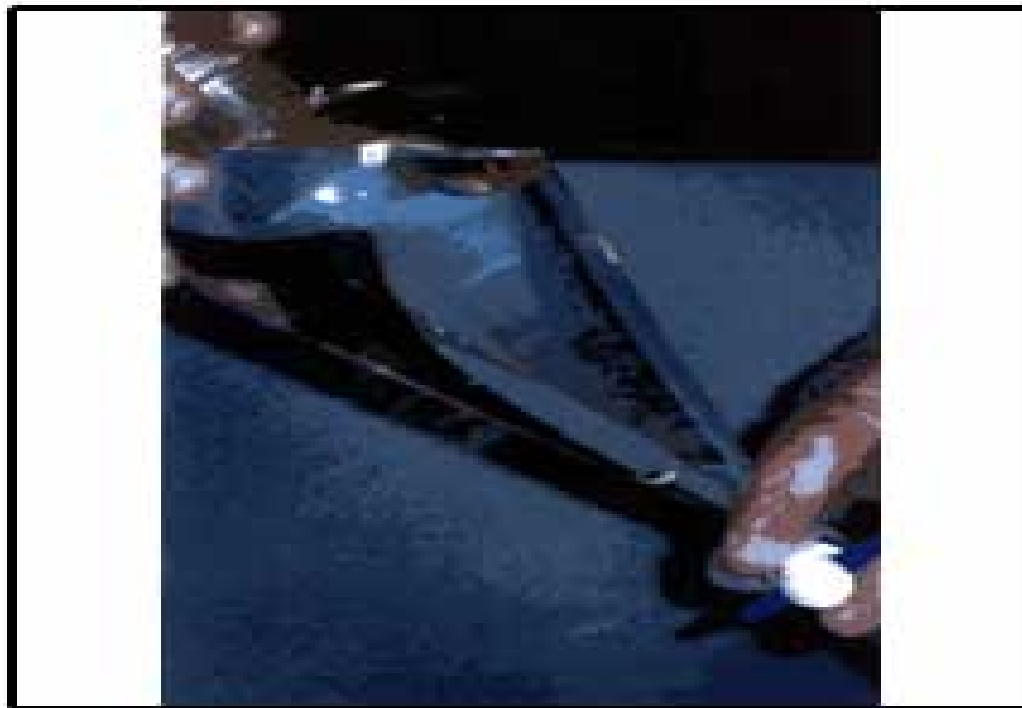
Step 3: *Swirl/Shake Sep Funnel To Extract*

3. Swirl separatory funnel to extract

3. Swirl separatory funnel to extract

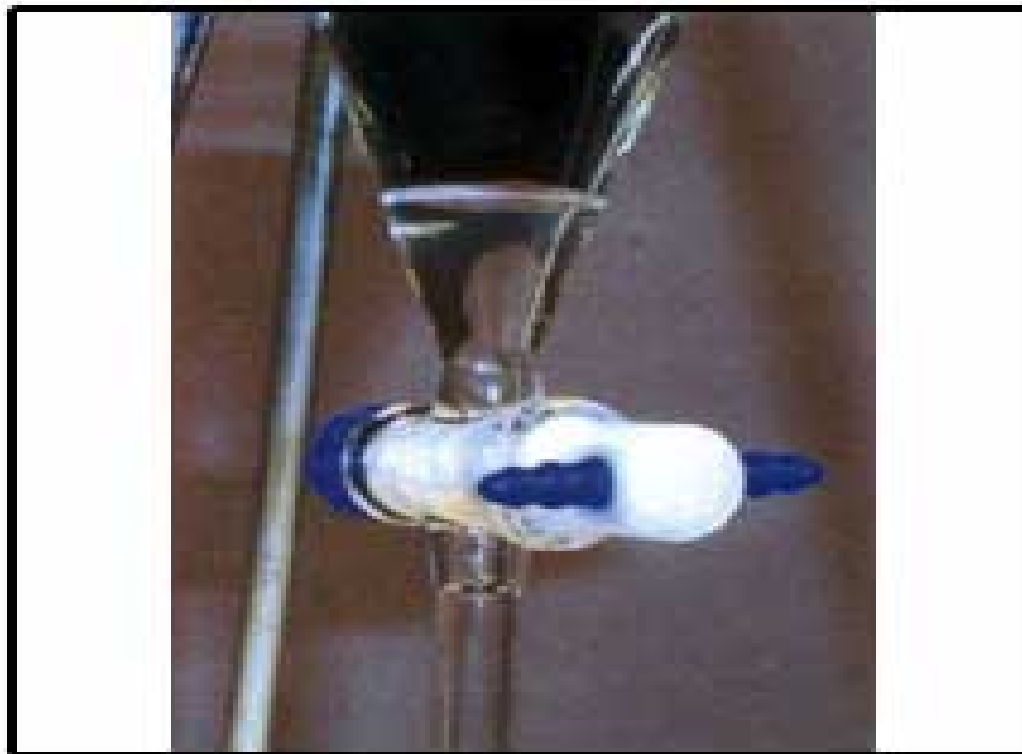
Step 4: *Let Extraction Layer Separate*

4. Let layers separate.

4. Let layers separate.

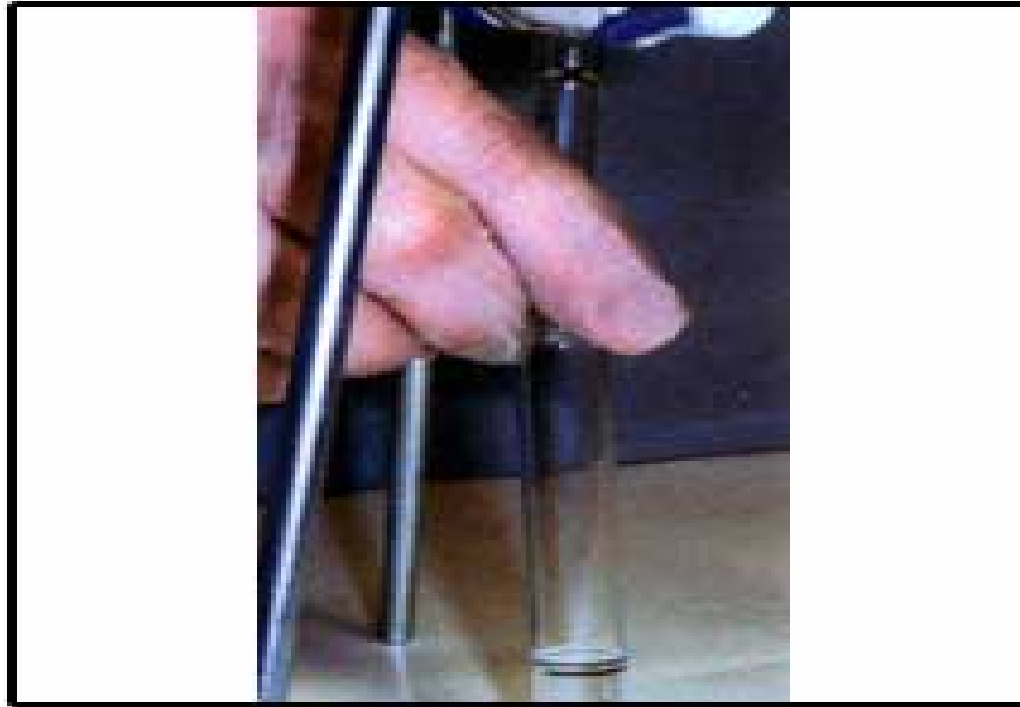
Step 5: *Drain Extract Solvent Into Test Tube*

5. Drain solvent into test tube.

5. Drain solvent into test tube.

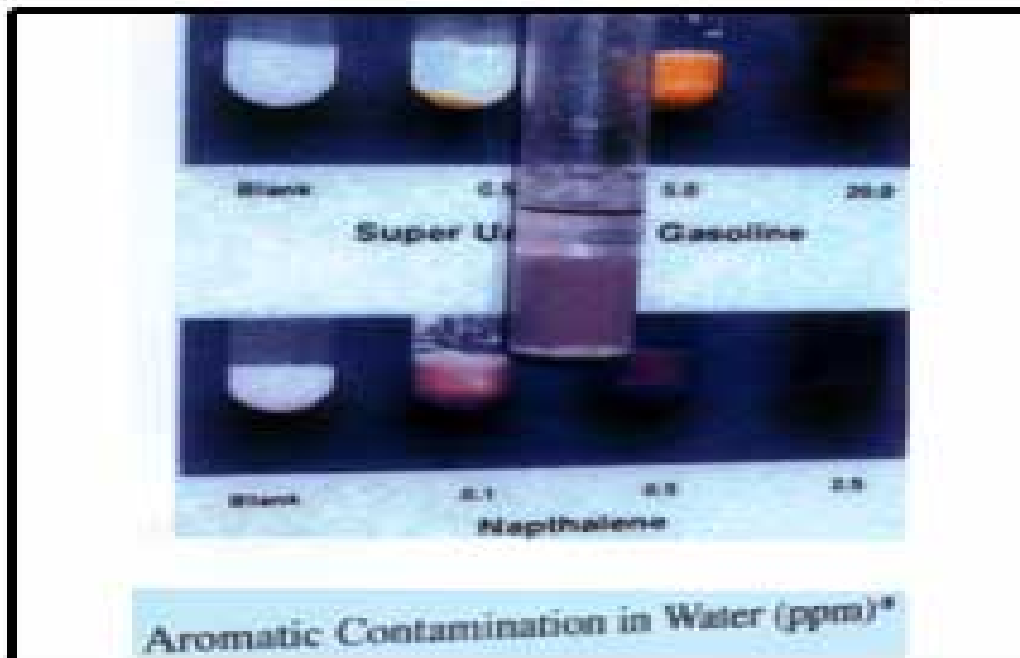
Step 6: *Add Catalyst, Shake and Compare to Standard Photo*

6. Add catalyst, shake, compare.

6. Add catalyst, shake, compare.

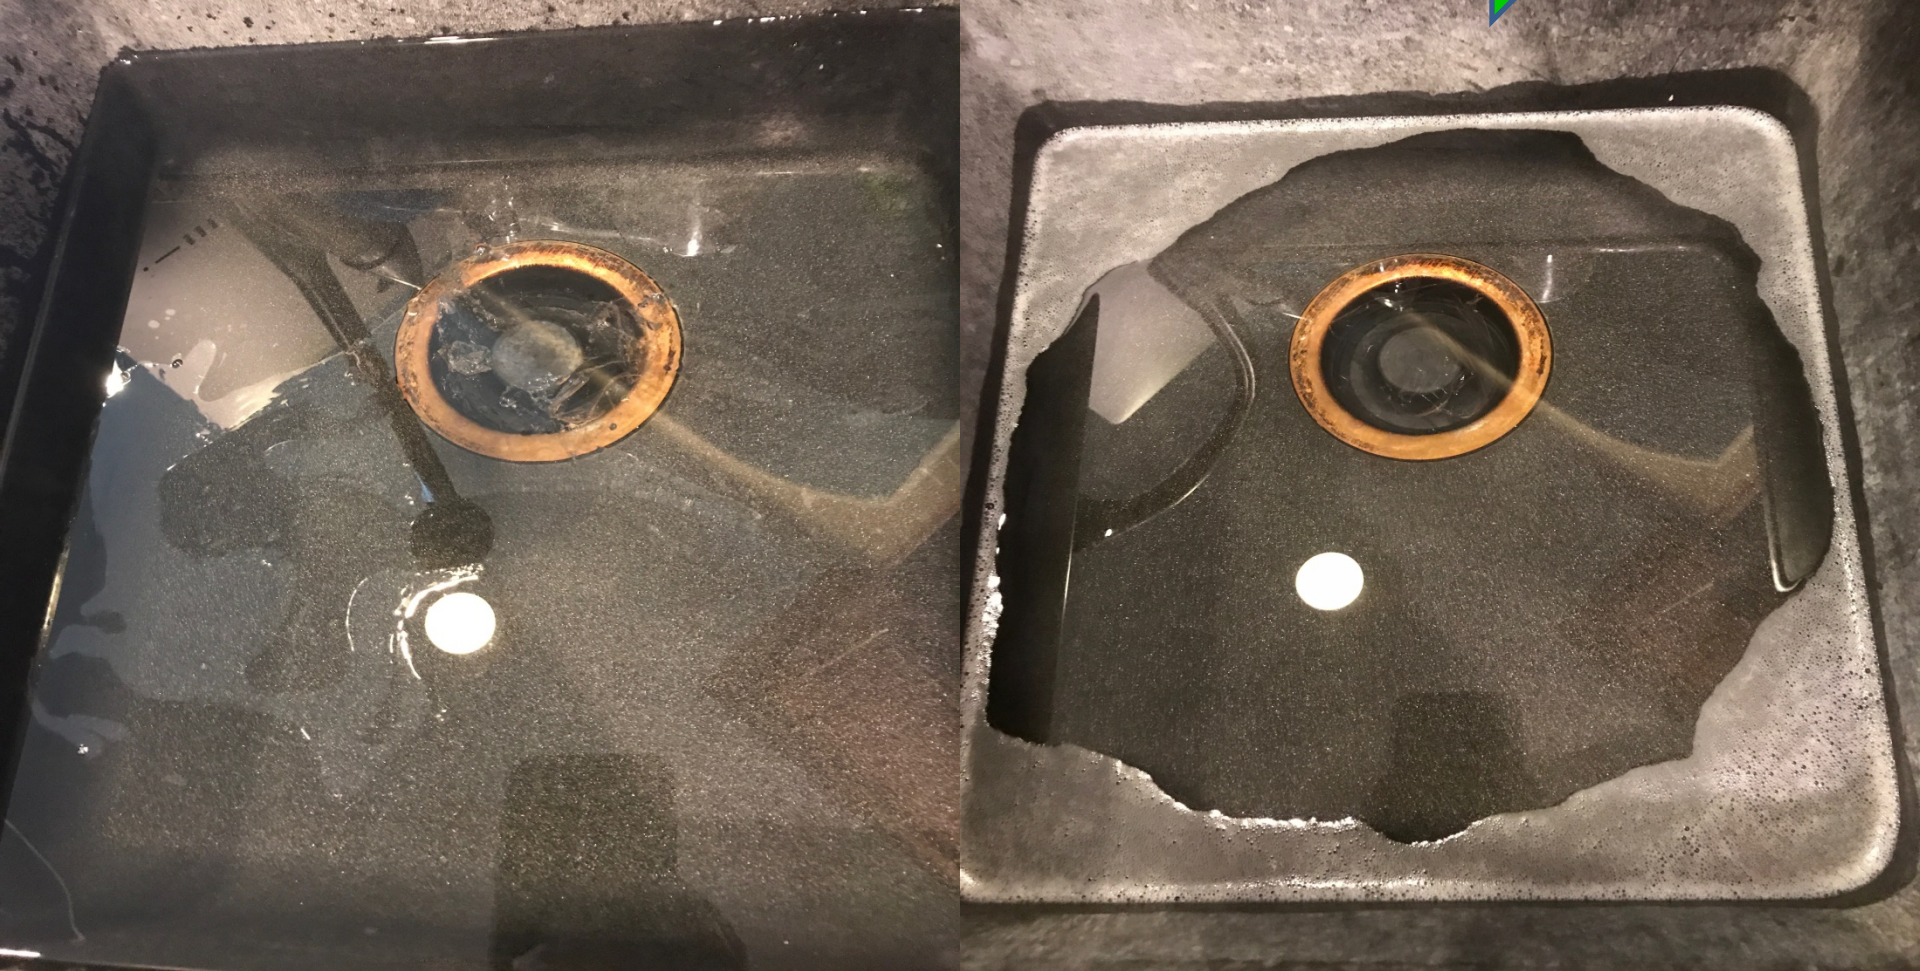
Water With Gasoline Sheen Pre / Post Treatment by ELMN8+

This was an initial test, no concentration measurements

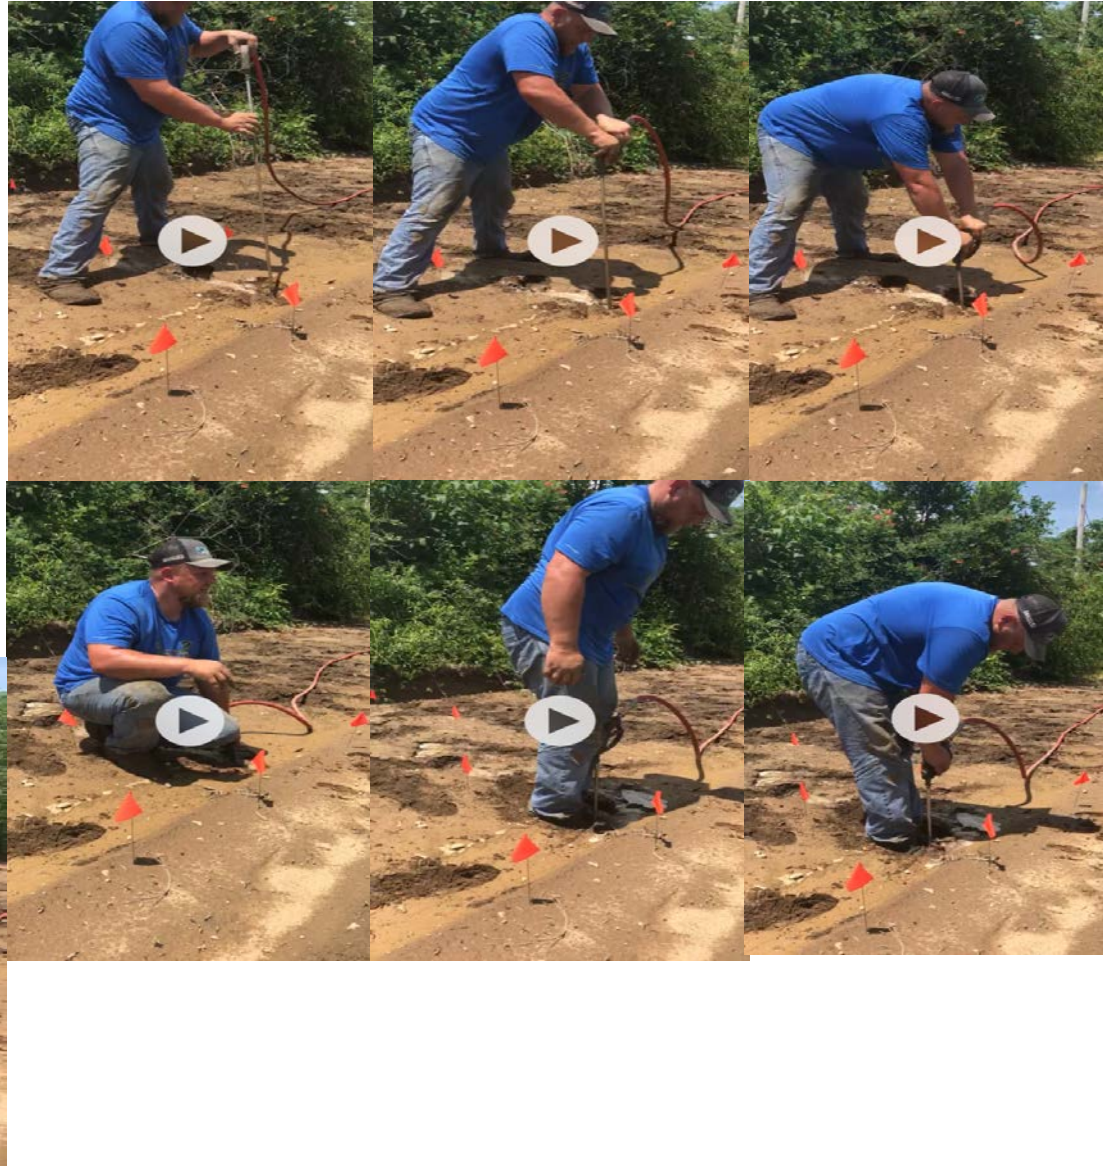
OMG's Soil Treatment Process

When Soil Has Infrastructure Treatment Process

- Normal Soil Treatment Process on Surface
- Drill Holes and Inject Water if needed due to a dry environment or
- Followed by Injection of **The Solution**
- **The Solution Migrates Thru The Same Path The Contamination Took**

Step 1: Saturate Contaminated Soil with Water and Follow by Treatment by ELMN8:

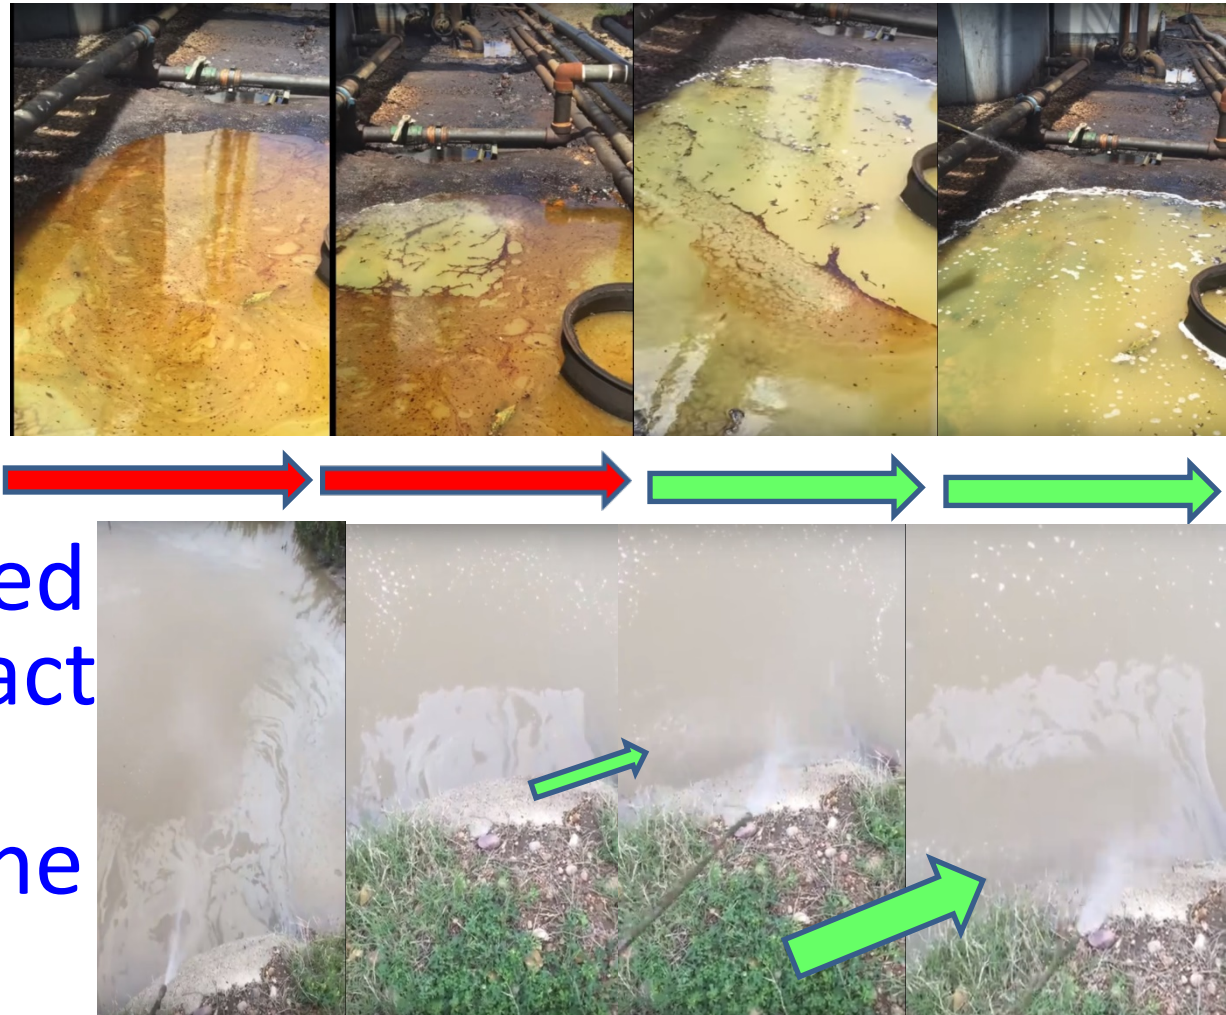
OMG's Water Treatment Process

The Water Treatment Process

- Contaminated Water Boomed Off
- **The Solution** is added
- Water is Agitated to Create Contact Between **The Solution** and The Contamination

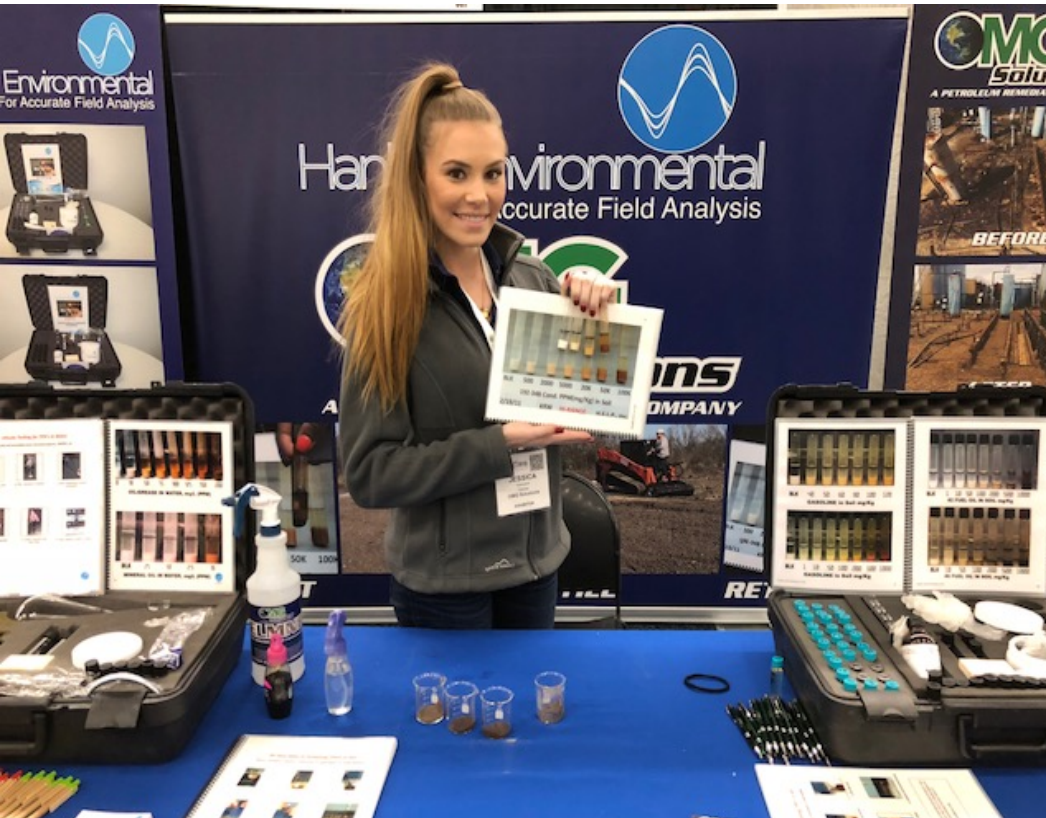
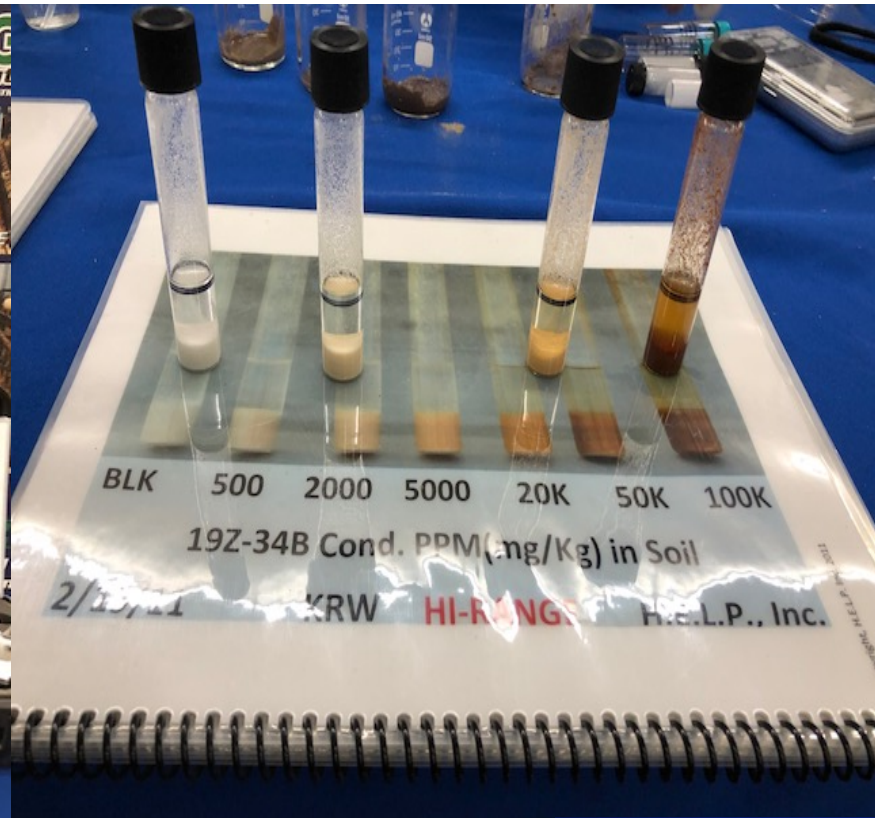
Typical Soil Test Results:

Clean Soil, Contaminated Soil to 125.5k ppm,
Reduced to 24.4k ppm, Reduced to 1.1k ppm by Two
Treatments of ELMN8

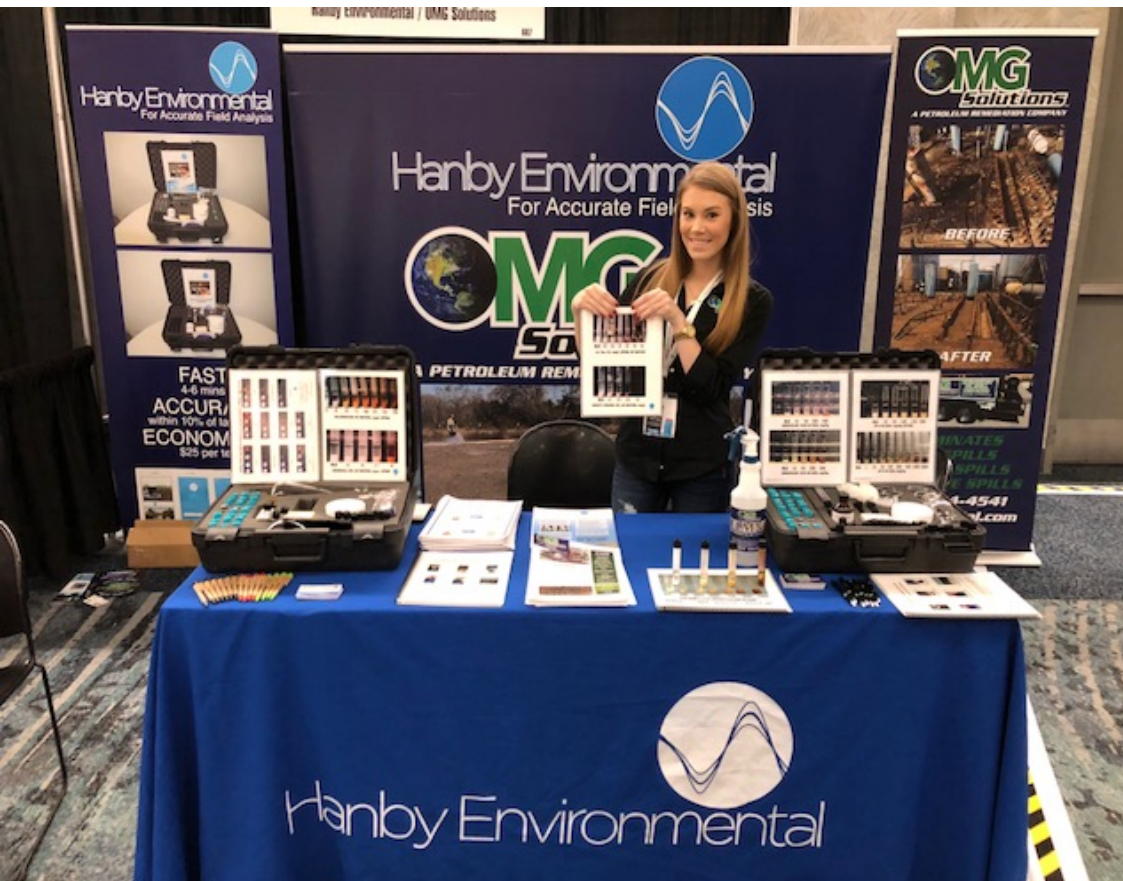
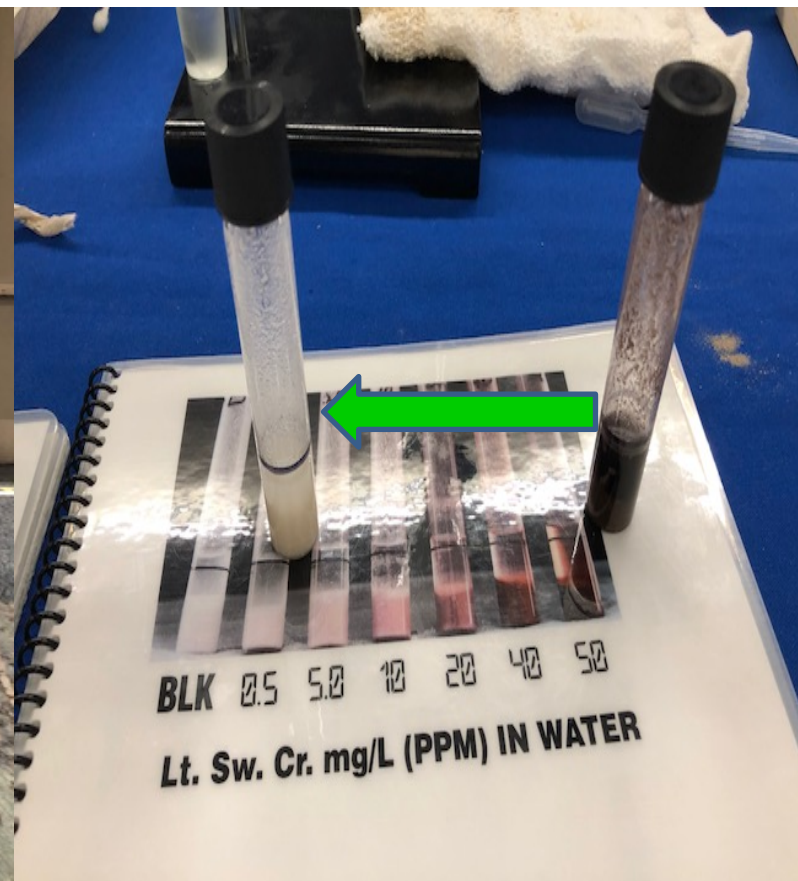
Typical Water Test Results:

Clean Water, Contaminated Water to 48.5 ppm,
Reduced to 7.7 ppm by One Treatment of ELMN8+

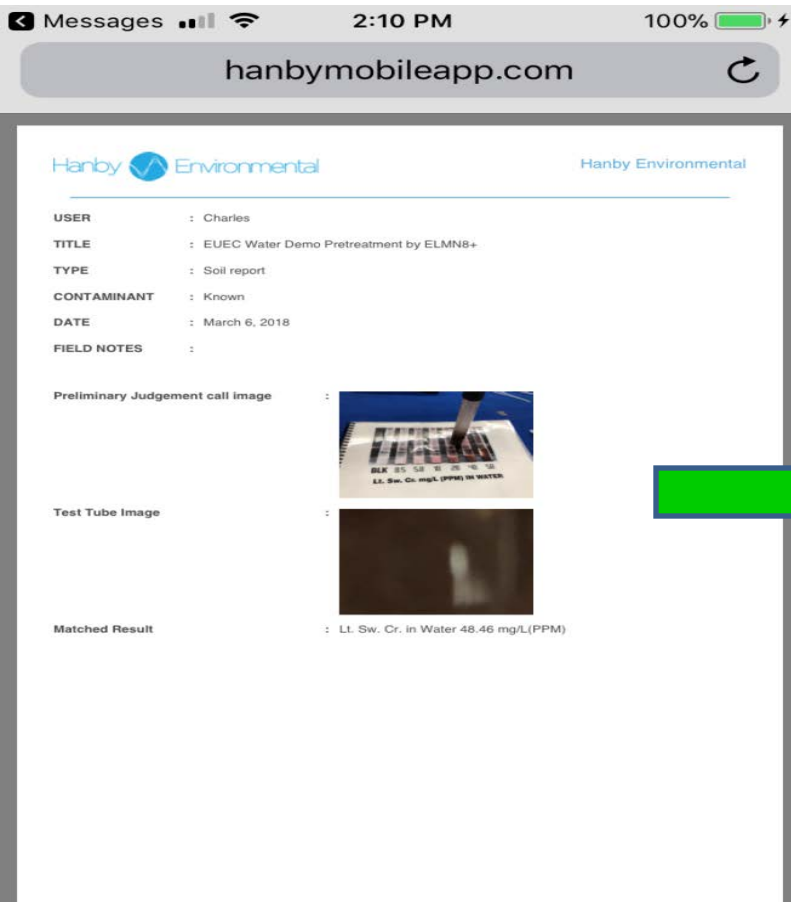
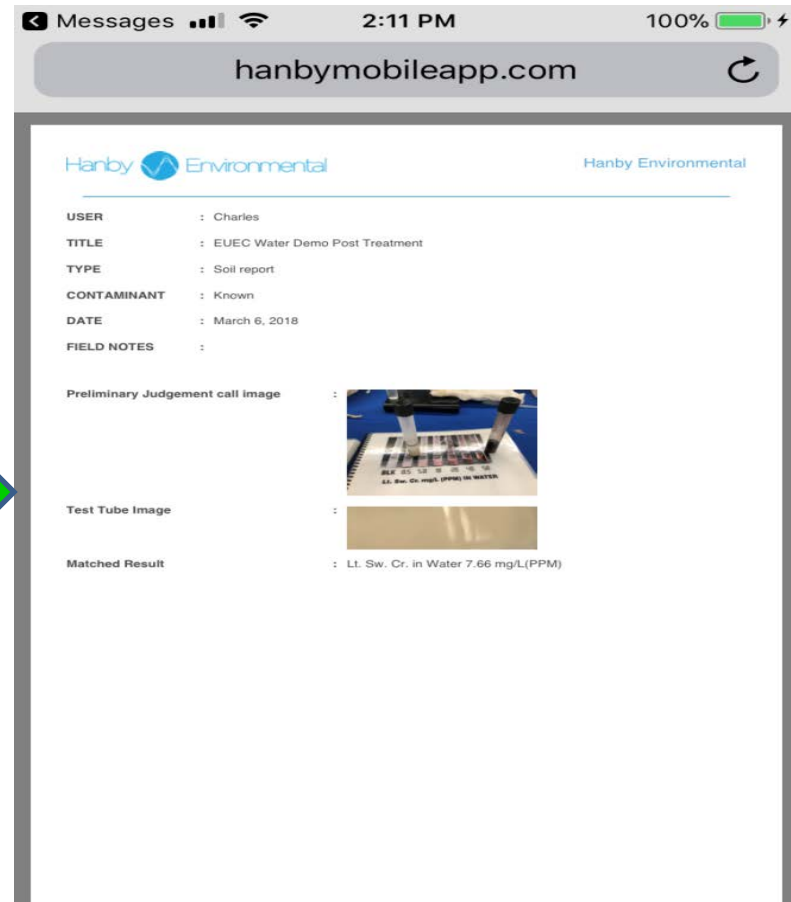
Water Treatment Validation Results Per

48.5 and 7.7 ppm

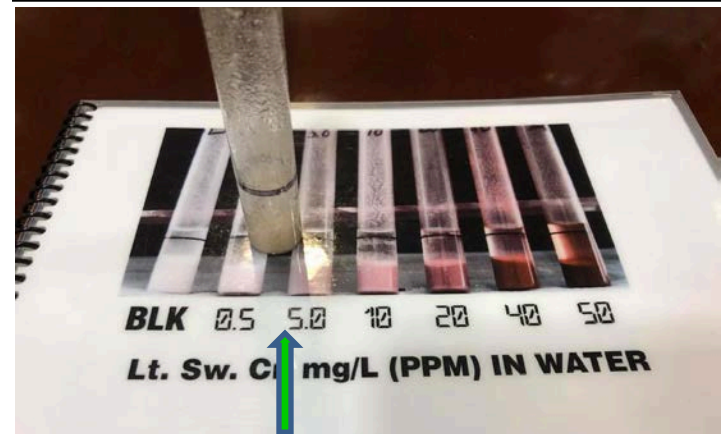
Water Sample - Pre (52 ppm) and Post (6.7 ppm) Treatment by ELMN8+
