# LITHIUM-ION BATTERY CASE STUDIES, CHALLENGES AND LESSONS LEARNED

Leon Wirschem, County of San Diego DEHQ-HIRT,

# San Diego Lithium-Ion Battery StudyDEHQSDFDEPA

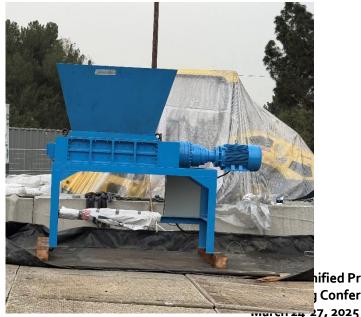
#### On-Site Shredding Bulk Packaging

## **Treatment and Disposal**

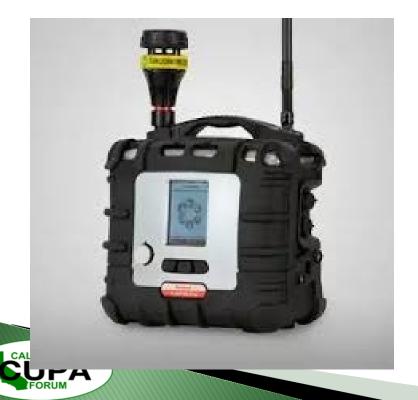
Air monitoring Made entry Continuous area monitoring Water runoff testing EPA coordination Private contractor coordination

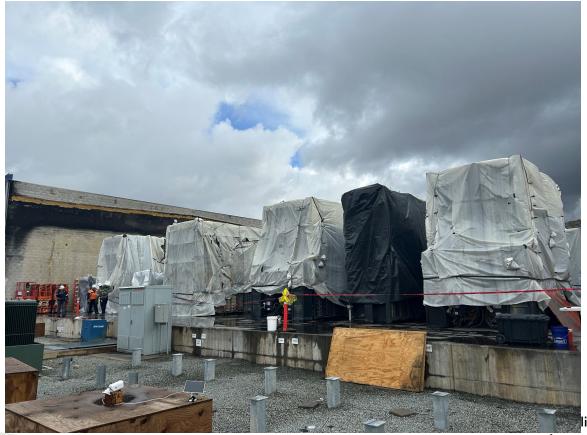
Roof removed, Battery racks wrapped to prevent rain impacts

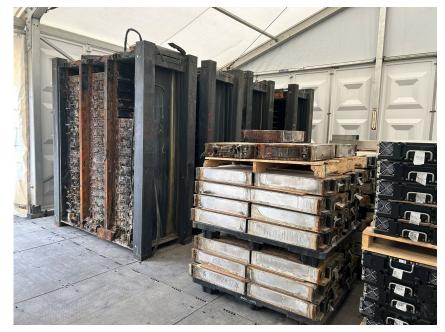
Staging, Assess voltages, remove battery cases

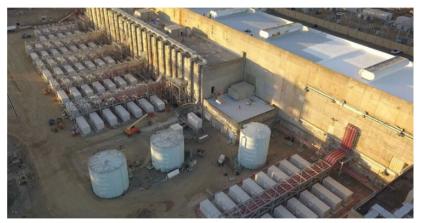
# Vistra completes world's largest BESS at Moss Landing

Vistra has completed construction on Phase II of its Moss Landing Energy Storage Facility in

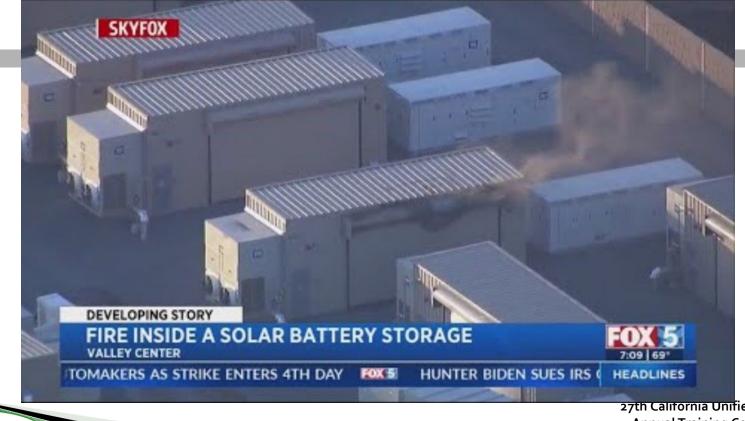
## Valley Center BESS Fire 9-2023

One Li lon battery storage structure was involved in a fire at this ESS. This structure housed approximately 133,000 Lbs of LIBs. Initial fire response observed flames and a light gray smoke at top of structure, indicating a battery fire. All battery storage structures are equipped with a sprinkler deluge system that activates automatically at high temperatures, flames or smoke. Fire suppression was actively discharging when fire personnel arrived. Fire companies took a defensive posture measuring temperature of structure with a thermal imaging device. Providing cooling of surrounding structures as needed. No personnel approached closer than 75 ft. Upon arrival at scene, no flames or smoke visible and storage container showed a cooling trend by thermal imaging device of fire personnel. Facility emergency representative and IC stated Facility Emergency Response Plan had been implemented and followed for a Thermal Runaway event. That no personnel were to approach closer than 75 ft of container for up to multiple days. Part of the Emergency Response plan that was initiated was an evacuation order of the nearest home, and shelter in place of homes in the downwind side within 1/4 mile.

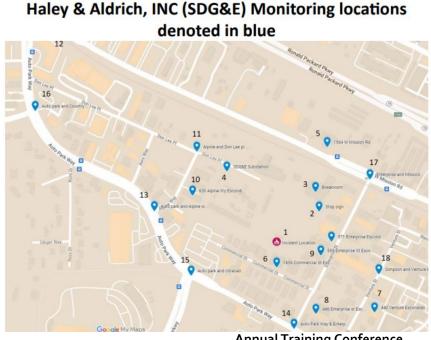
#### SD County Hazmat Readings in Parts Per Million (PPM)

Location	Distance from Incident (ft)	Time	PH3	CL2	H2S	CO2	HCN	со
Main Gate	315	14:30	0	0	0	0	0	0
Venture and Simpson	784	14:35	0	0	0	0	0	0
State St (All	1447	14:36	0	0	0	0	0	0
Enterprise and Auto Park	776	18:15	0	0	0	0	0.5	0
Enterprise Gate	262	18:16	0	0	0	18	2	0
Venture and Simpson	784	18:21	0	0	0	0	0.5	0
Venture and State	1108	18:22	0	0	0	0	0.5	0
Market and Auto Park	2227	18:25	0	0	0	0	0	0
Vinewood and Industrial	2280	18:27	0	0	0	0	0.5	0
Andreasen and Simpson	2522	18:29	0	0	0	0	0.5	0
1287 Simpson	3943	18:32	0	0	0	0	0.5	0

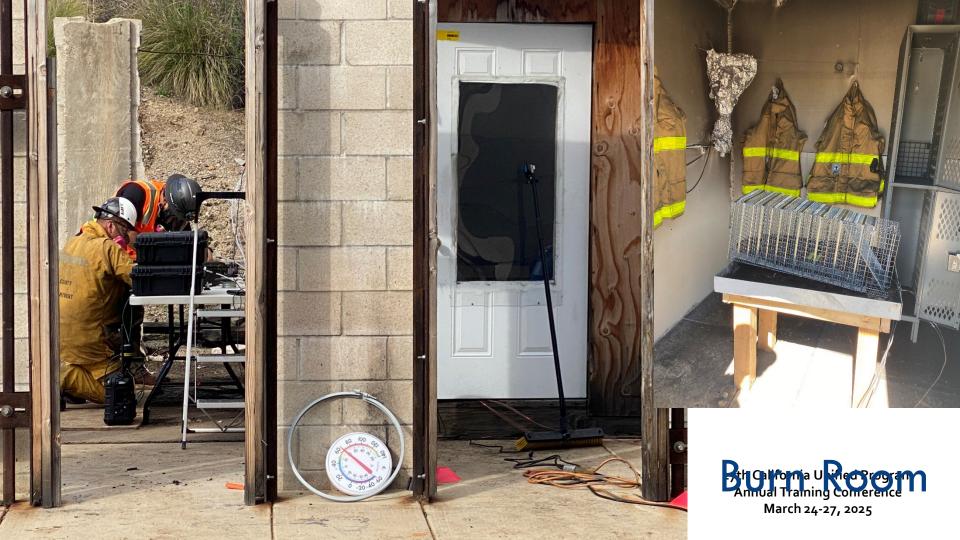
- A simulated fire room with four walls, a ceiling and a floor was constructed using typical construction materials. The front wall included plexiglass window for observation. Various holes were made in the room so monitoring equipment could draw air into the devices for measurement
- Method of causing thermal runaway involved the use of a heating element via 120V. The batteries and heating element were placed into a rat cage for safety and monitored until completion of the reaction.
- Batteries of LiFePo4 and NMC chemistry at various states of charge and configurations were tested.
- Data was collected during the thermal runaway event. Monitors for gasses, particles, pH and temperature were used.

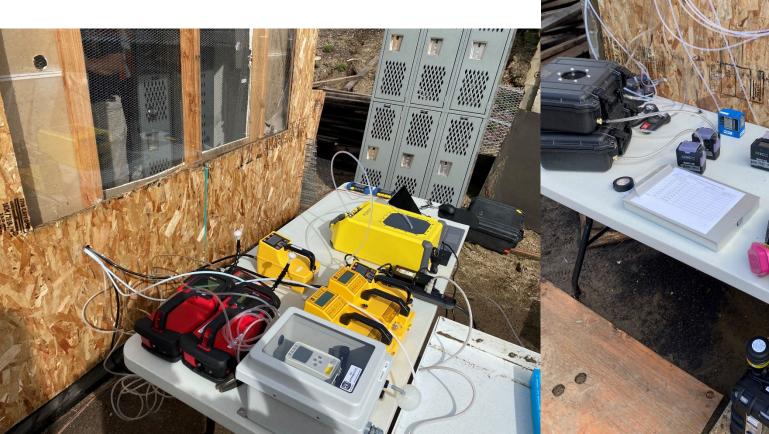
Red Wave ExplorIR, RKI Eagle, Gasmet, HoneyWell AreaRae, Honeywell Single-Point Monitoring (SPM) Flex unit with a mineral acid cassette

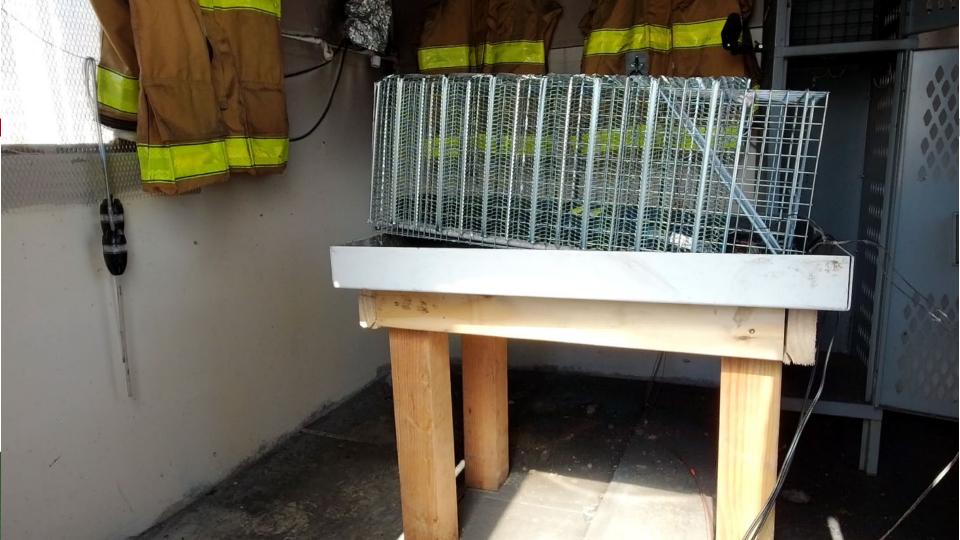
#### Battery Configurations

Thermal Runaway initiated via heating elements

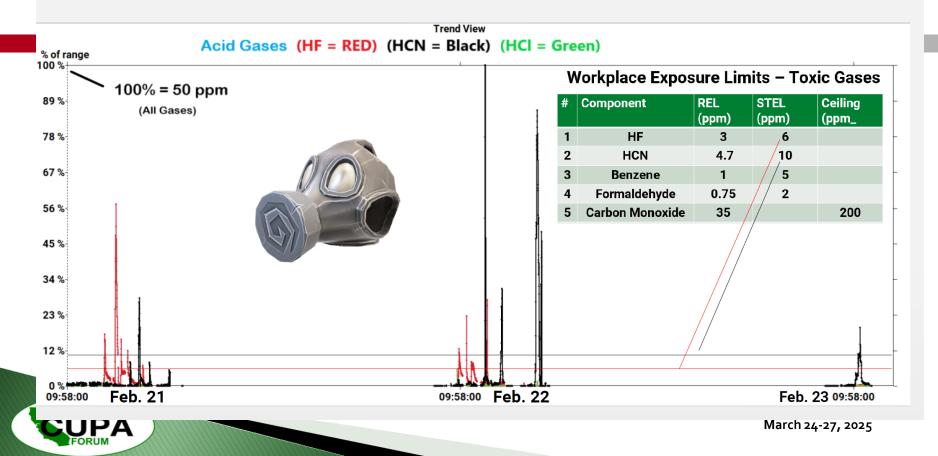
#### GT5000 gas analysis results

Ch	Component	Concentr	Range	Residua
0001	Water vapor	1.31	3	0.0009
0002	Carbon dioxide	14222.09	30000	0.0101
0003	Methane	154.33	2000	0.0049
0004	Nitrous oxide	0.64	100	0.0094
0005	Carbon monoxide	2018.39	1000	0.0099
0006	Hydrogen fluoride	0.16	50	0.0009
8000	Hydrogen cyanide	7.02	100	0.0019
0009	Dimethyl carbonate (DCM)	123.75	200	0.0232
010	Ethyl methyl carbonate (EMC)	8.89	200	0.0232
0011	Ethylene carbonate (EC)	1.73	100	0.0101
0014	Formaldehyde	17.31	50	0.0008
0016	Hexane	5.18	50	0.0046
0017	Benzene	22.36	50	0.0047
018	Ammonia	0.00	100	0.0067
0019	Acetaldehyde	6.12	200	0.0008
0020	Ethanol	7.84	200	0.0110
0021	Acetic acid	3.15	100	0.0103
0022	Methanol	17.71	200	0.0105
0023	Acetylene	35.16	200	0.0025
0024	Ethylene	98.44	200	0.0149
0025	Propene	23.11	200	0.0111
0026	Isopentane	7.26	200	0.0046
0027	Methyl acetate	0.65	100	0.0101
0028	Styrene	17.74	100	0.0046

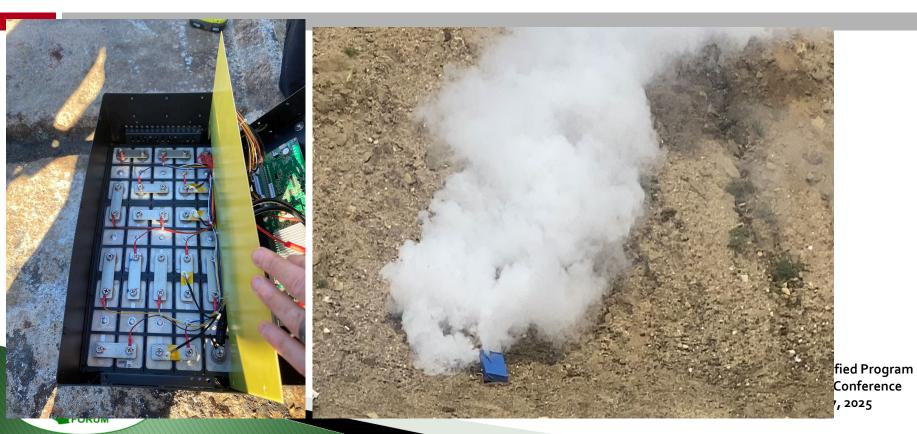
#### Toxic/Flammable Smoke from 1/15<sup>th</sup> of an ESS Batt

Eagle HF 9.00ppm Over (Over Range) / Eagle 2 VOC (PID) 1.0ppm / GX-6000, O2 22.3%, CO 3ppm, VOC (PID) 5.2ppm. All other sensors were reading zero or O2 at 20.9%.

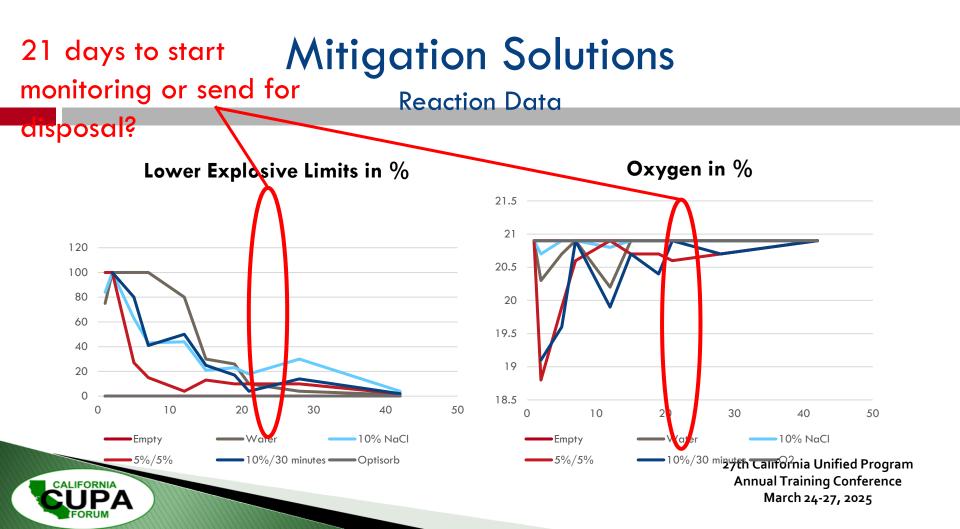
- Three burned batteries and three intact batteries at 100% state of charge were used to simulate a partially burned battery
- □ Five mitigation techniques used
  - 1. Empty metal container
  - 2. Water
  - 3. 10% NaCl in water
  - 4. 5% NaCl and 5% Sodium Bicarbonate in water
  - 5. 10% NaCl in water for 30 minutes then empty container
  - 6. Optisorb absorbent
- Each solution was made to two gallons and placed in a sealed container to capture reaction gasses.
- Containers were monitored periodically over 42 days using CGI, PID and MultiRae with CL2, NH3, PH3, CO and HCN

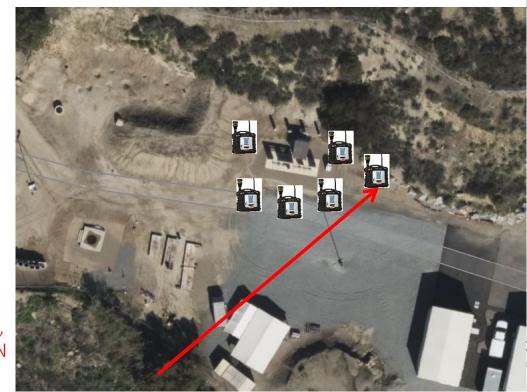
Day 3 Structure Burn. East Unit: 102ppm CO, 4.7ppm HCN

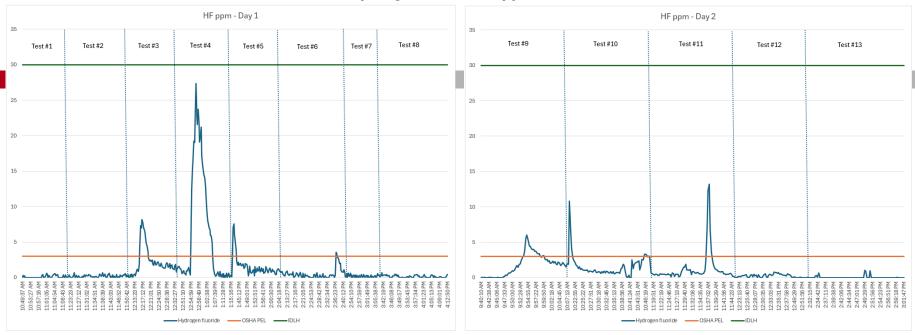
#### Hydrogen Fluoride - ppm

Test #	Description	Test #	Description
1	4 LiFePO4 18500 Solar - 100% SOC	8	65 NMC KULR Ebike & Amazon 18650
2	4 LiFePO4 18500 Solar	9	18 NMC Mollicel ISS 21700 - 100% SOC
3	8 LiFePO4 18500 Solar - Low SOC	10	2 LiFePO4 ESS (Prismatic) - 1 charged, 1 uncharged
4	8 LiFePO4 18500 Solar - 100% SOC	11	48 NMC Zhejang skateboard 21700, <40V
5	12 NMC (Nuon) 18650 - 100% SOC	12	48 NMC Zhejang skateboard 2770h 100 to the Unified Program
6	44 NMC 21700 Zhejang Skateboard - 100% SOC plus some reacted cells	13	3 x NMC Zhejang Skateboard in Akanalia of raining 6, and even se
7	on		March 24-27, 2025

- We confirmed the presence of HF. More analysis of the data needed to see when it is higher concentrations i.e. smoking, on fire, exploding...and how long present
- Confirmed H2 present in room and in waste container
- HF and H2 can exceed IDLH
- Full SOC more hazardous/reactive.
- Batteries don't need a heat source (heating element) to go through thermal runaway:
- Can be more projectile than expected
- Some types like LiFePO4 took longer for thermal runaway, could present more vapors if they are not consumed with higher temperatures.
- Water works to discharge batteries with intact terminals
- Turnouts can get metals in them. Waiting on UCLA data. Other data from Texas A&M here: https://teex.org/ev-ess-current-practices/

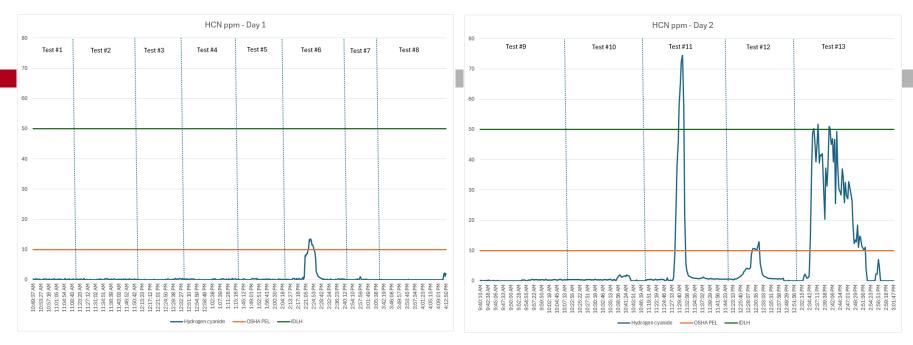
#### Hydrogen Cyanide - ppm

Test# [	Description	Test #	Description
1 4	4 LiFePO4 18500 Solar - 100% SOC	8	65 NMC KULR Ebike & Amazon 18650
2 4	4 LiFePO4 18500 Solar	9	18 NMC Mollicel ISS 21700 - 100% SOC
38	8 LiFePO4 18500 Solar - Low SOC	10	2 LiFePO4 ESS (Prismatic) - 1 charged, 1 uncharged
48	8 LiFePO4 18500 Solar - 100% SOC	11	48 NMC Zhejang skateboard 21700, <40V
5 1	12 NMC (Nuon) 18650 - 100% SOC	12	48 NMC Zhejang skateboard 21700, 440 48 NMC Zhejang skateboard 21700, 440
6 4	44 NMC 21700 Zhejang Skateboard - 100% SOC plus some reacted cells	13	3 x NMC Zhejang Skateboard in Akang Hirado Training 6,9 af erance
7 8	on		March 24-27, 2025
