Inspection of Above Ground Storage Tanks

▶ Presented by: Alex Romanow Jr.

**22nd Annual California
CUPA Training
Conference**

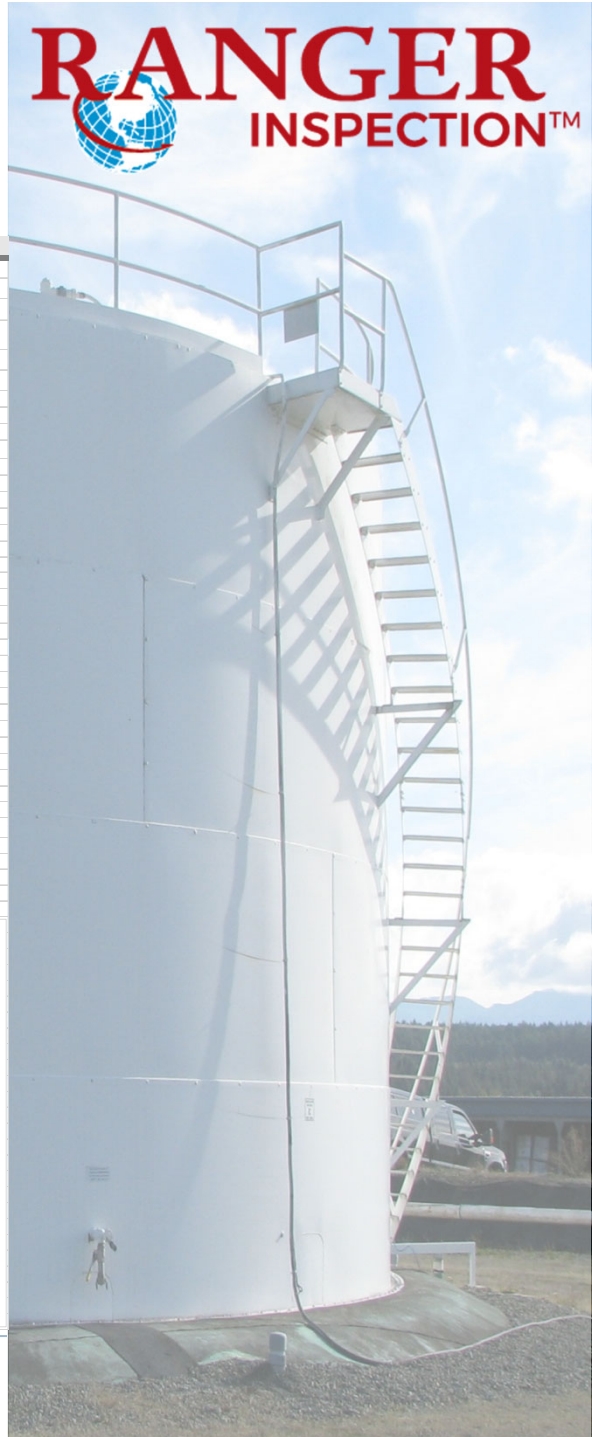
Foundation Settlement

INPUTS				
Tank ID ↓	Tank radius (Feet) ↓	Shell Height (Feet) ↓	Bottom Course Material Specification ↓	Landmark at 0° ↓
1009	60.00	49.75	A131-A,B,CS	Manway A

Station #	Angle°	Elevation	
i	CCW	Feet	
0	0	6.824147	
1	30	6.824147	
2	60	6.811024	
3	90	6.801181	
4	120	6.781496	
5	150	6.794619	
6	180	6.771654	
7	210	6.768373	
8	240	6.788058	
9	270	6.791339	
10	300	6.801181	
11	330	6.817585

OUTPUTS			
L (ft)	Y (psi)	E (psi)	Smax (ft)
31.41592654	34000	29000000	0.12792

Station #	Out-of-Plane Settlement	Deflection	Permissible by B.3.2.1? ["Yes", "No"]
i	Ui	Si	
0	0.001612	0.002500	Yes
1	0.002578	0.000110	Yes
2	0.003325	0.003491	Yes
3	-0.002909	0.003788	Yes
4	-0.001567	0.004272	Yes
5	-0.008769	0.015381	Yes
6	0.014793	0.020466	Yes
7	-0.002578	0.006672	Yes
8	-0.006606	0.008412	Yes
9	0.006190	0.010350	Yes
10	-0.001714	0.002631	Yes
11	-0.004355	0.004304	Yes

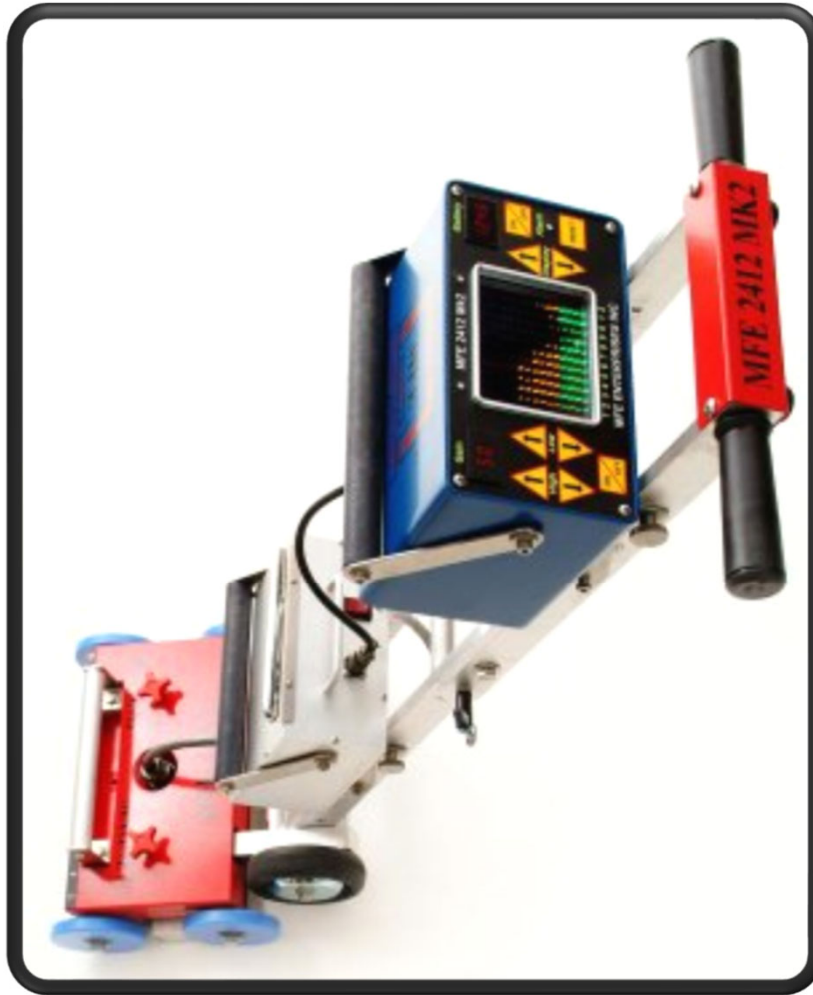
MFE 2412 Mark II

- ▶ Manually operated
- ▶ Weight = 110lbs
- ▶ Long battery life
- ▶ Easy to read/use display
- ▶ Rugged Design
- ▶ Folds down for easy transport
- ▶ 28" x 19" x 18" container in line with IATA (International Air Transport Association) requirements
- ▶ Manageable with one crew member

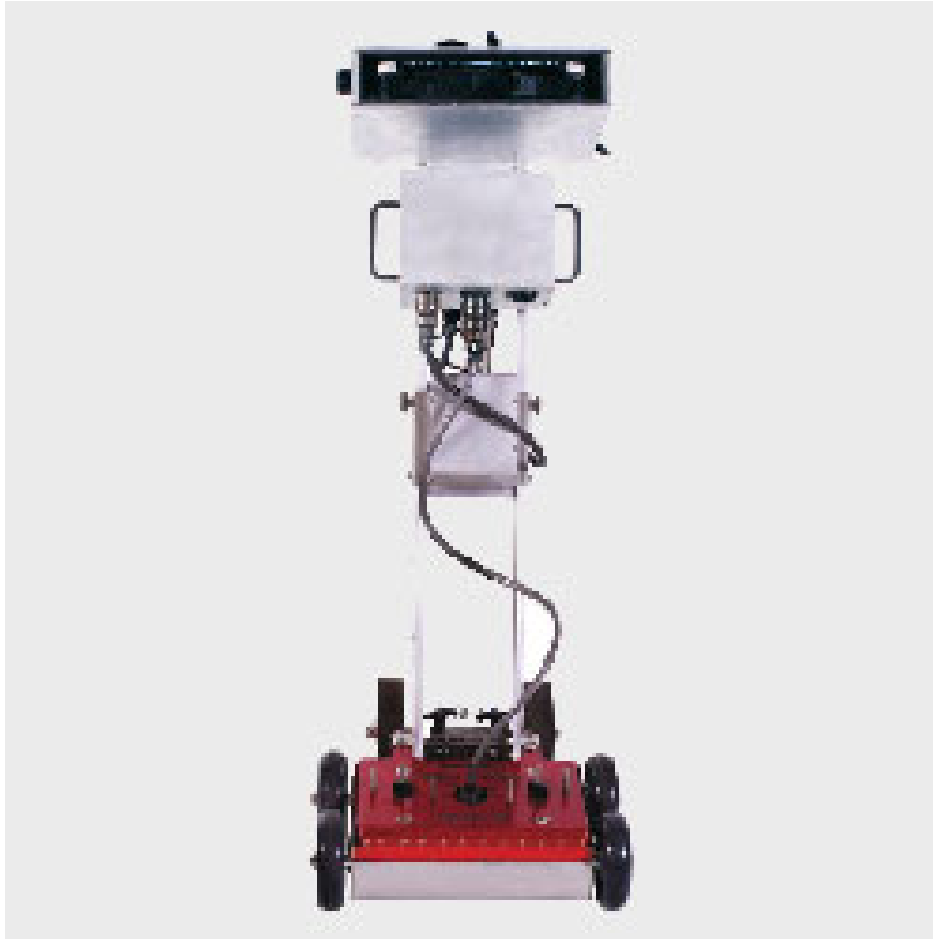
MFE Mark III

- ▶ Manually operated
- ▶ Weight = 100lbs
- ▶ Long battery life
- ▶ Rugged tough screen
Panasonic Toughbook
display
- ▶ Improved magnetic
bridge for higher
sensitivity through coated
floors
- ▶ Manageable with one
crew member

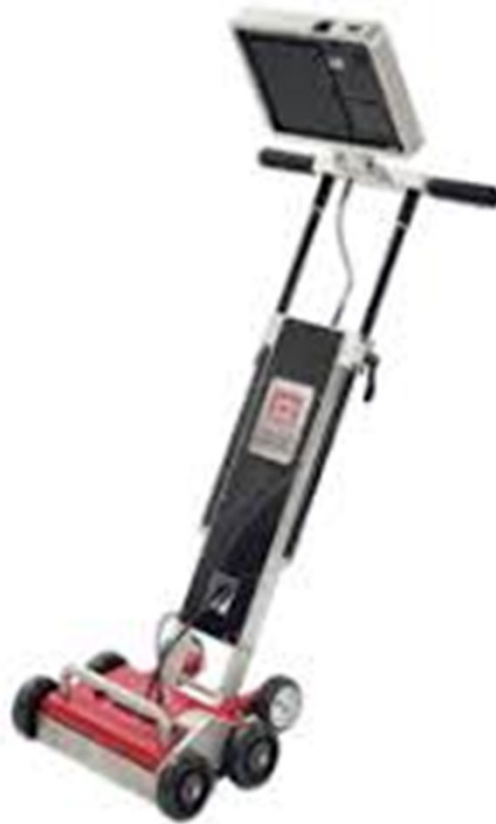
MFE Mark IV

- ▶ The Mark IV takes the precision, reliability, and durability of its predecessors to another level with upgraded, user-friendly software and a lightweight build. Its slim design boasts an unprecedented weight of only 65 lb.
- ▶ The real-time “A-Scan” display features an LED signal response that runs concurrently with a “C-Scan” mapping preview that clearly illustrates where the defect is relative to the magnetic bridge. This allows defects to be located even faster and drastically eliminates the needs of the scanner to be constantly moving while locating defects.
- ▶ The new speed tracking feature provides the operator immediate feedback so they are confident they are scanning within an optimal speed range, ensuring consistent, reliable, and accurate results.

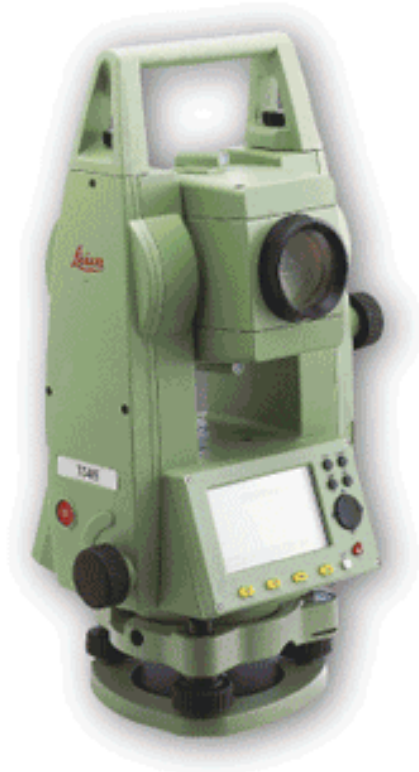
Laser Level / Total Station

- ▶ Leica Geosystems Total Station TCR403 Ultra R300
- ▶ Leica Geosystems Rugby 100

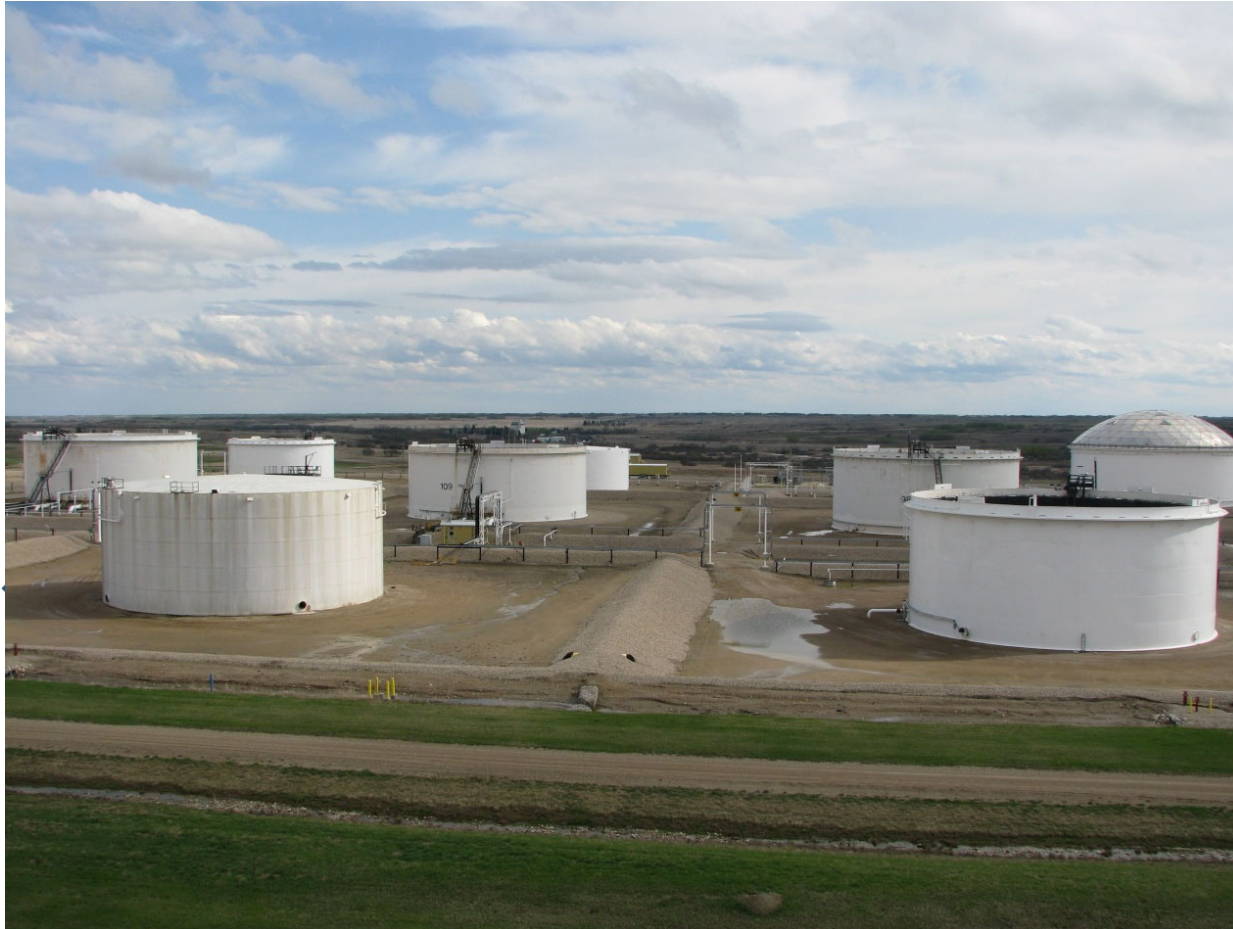
STC Measurement Procedures

- ▶ All STC Data Collection Procedures Comply with the Manual of Petroleum Management Standard – Chapter 2
- ▶ Based on Customer Requirements and/or Tank Construction we are Able to Select Which Method to Use for Storage Tank Calibration
 - ▶ MPMS Section 2A – Manual Tank Strapping Method
 - ▶ MPMS Section 2B – Optical Reference Line Method
 - ▶ MPMS Section 2C – Optical Triangulation Method
 - ▶ MPMS Section 2D – Internal Electro-optical Distance Ranging Method

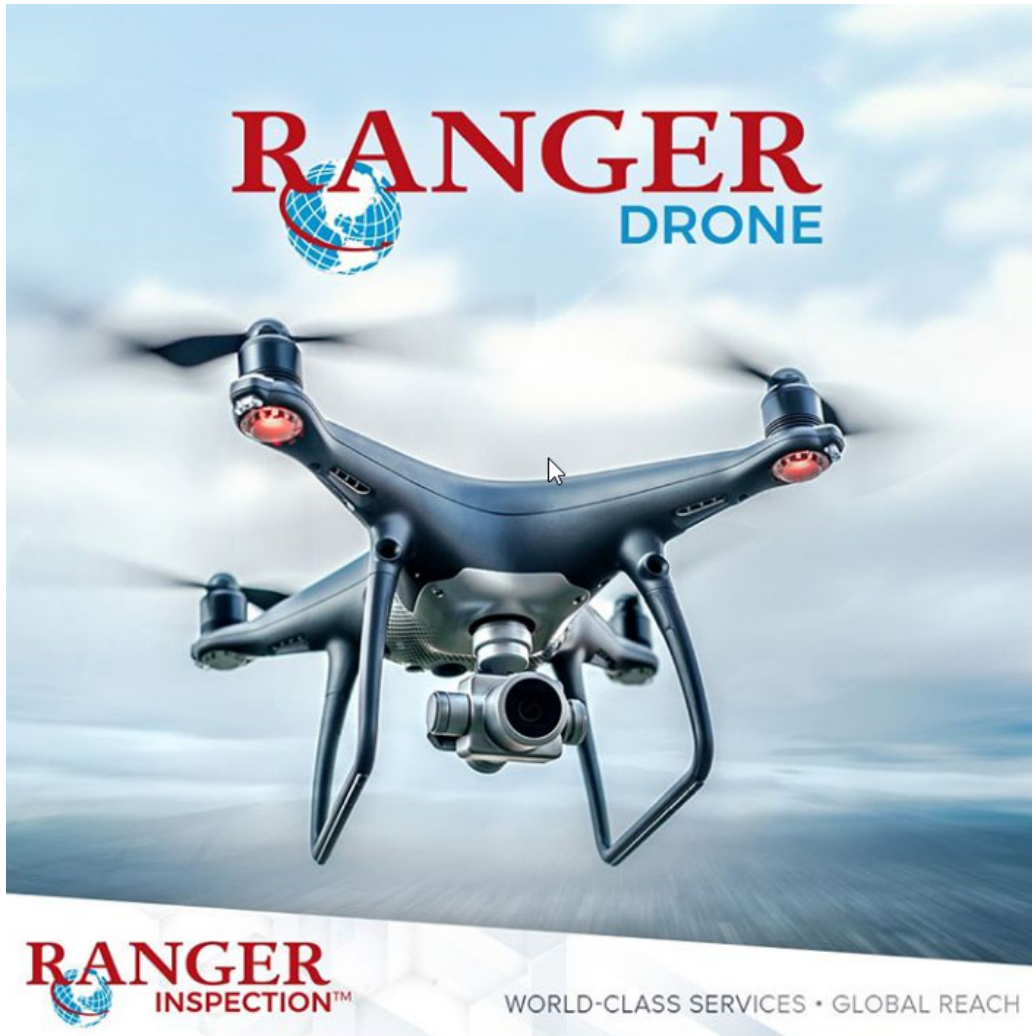
Ranger Drone

- ▶ Inspection of Tanks, Pressure Vessels, Piping, Towers, Stacks
- ▶ Refineries, Tank Farms, Oil & Gas Facilities
- ▶ Marine, Mining, Agriculture, Construction, Exploration
- ▶ Inspection of Bridges, Beams, Girders
- ▶ Confined Spaces, Sumps, Corridors
- ▶ Inspection of Welds, Corrosion, Coatings, Surfaces
- ▶ Buildings, Rooms, Attics, Crawl Space, Tunnels
- ▶ Search & Rescue, Reconnaissance
- ▶ Military / Police / Security
