Why is API 653 Relevant to AP5A?

Andrew Yearwood, PEMY Consulting, LLC.

27th California Unified Program
Annual Training Conference
March 24-27, 2025

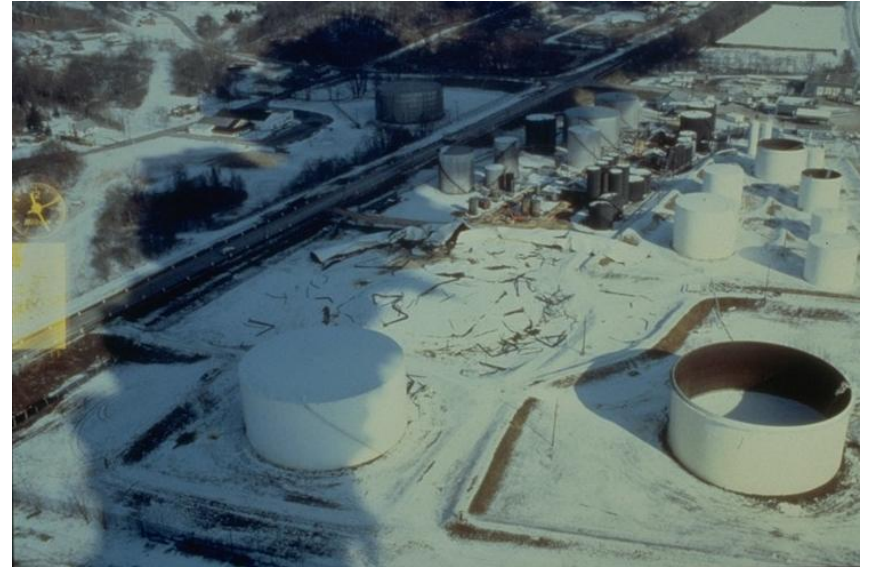
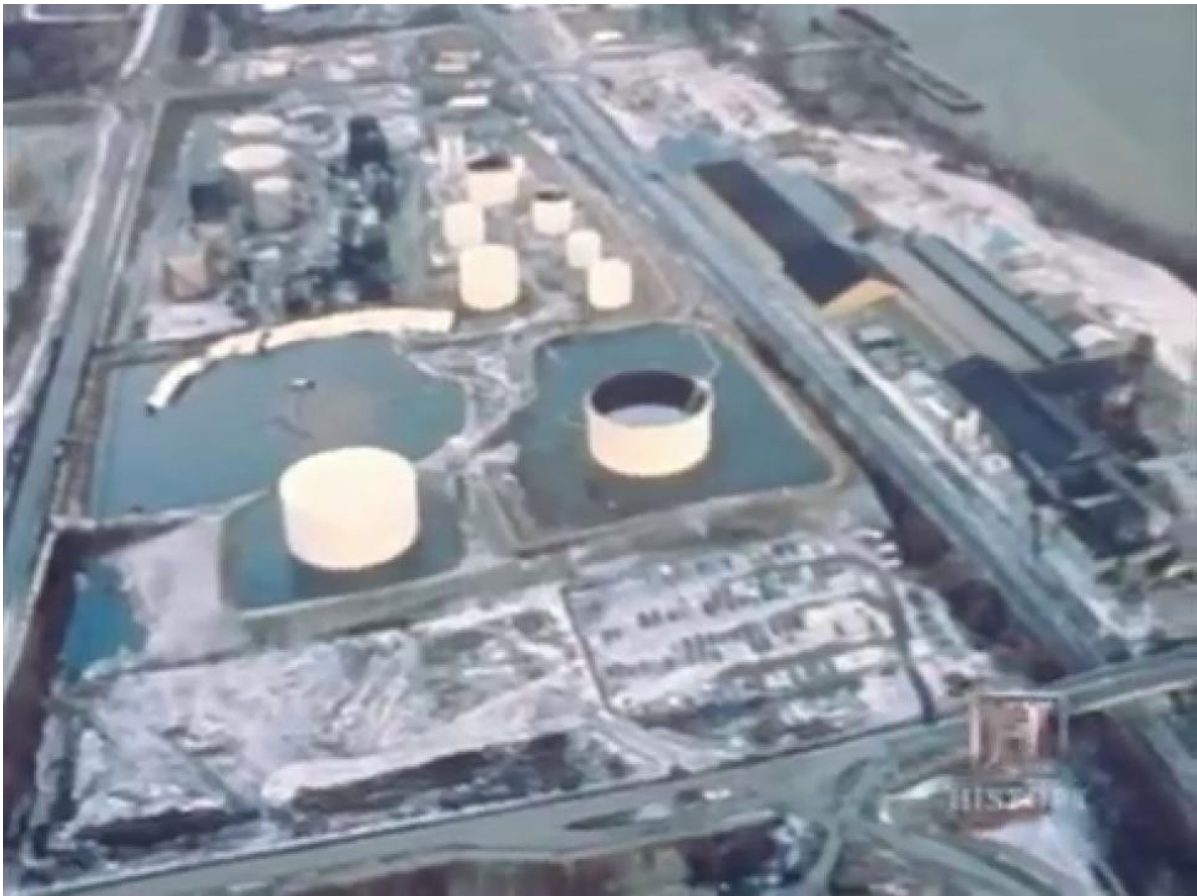
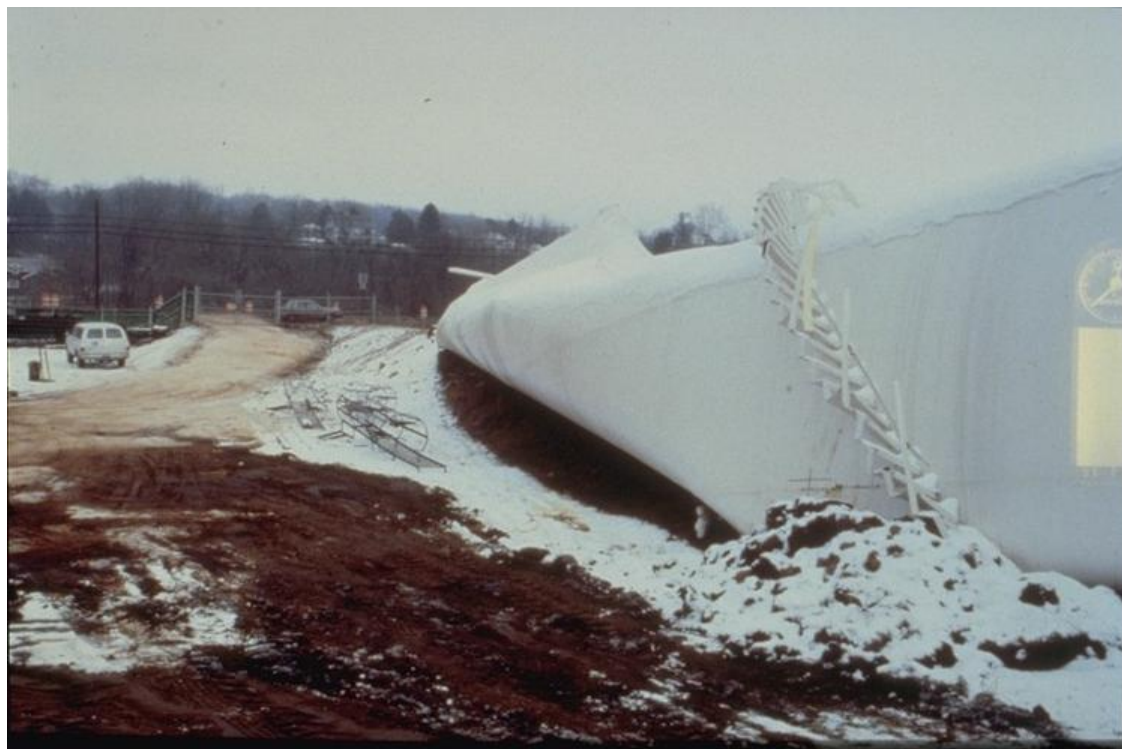
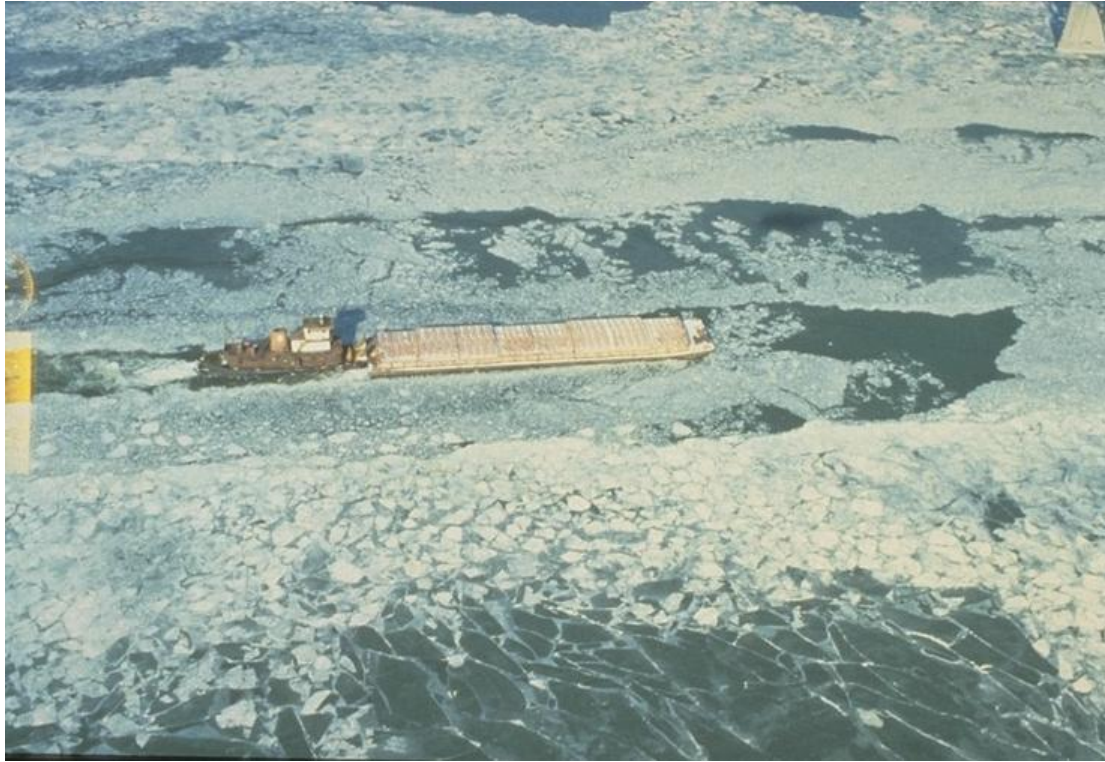
A Defining Moment for Tanks

- January 2, 1988
- Recently reconstructed tank was filled completely with diesel. 4M gallons.
- Extreme cold, -12F
- Sudden catastrophic failure of the tank – Brittle Fracture
- All contents released, spilled over dike, and into Monongahela River then to Ohio River.

1/2 to 1 million gallons spilled into river. \$2M fine.

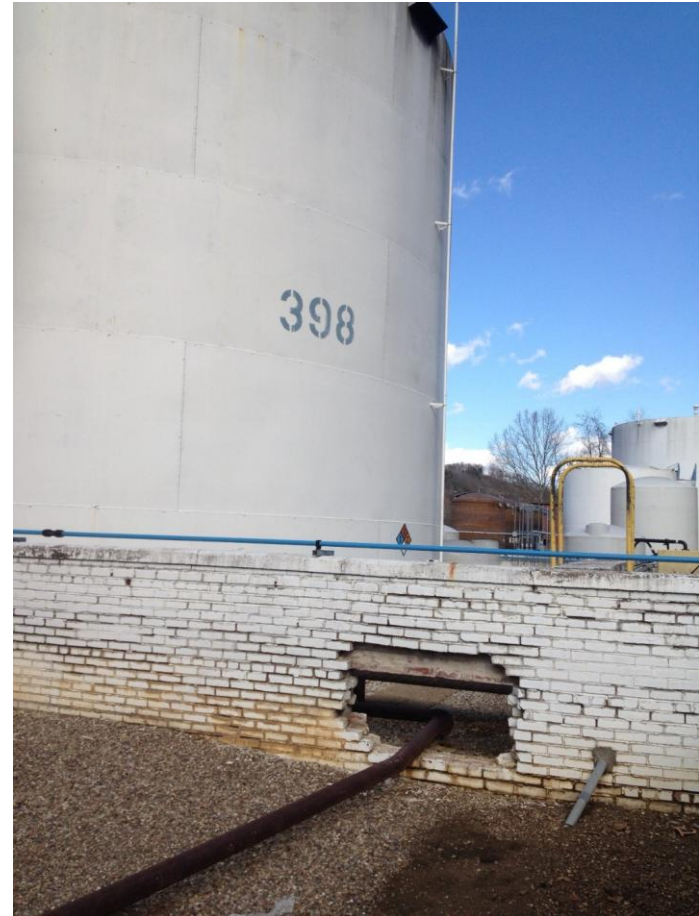
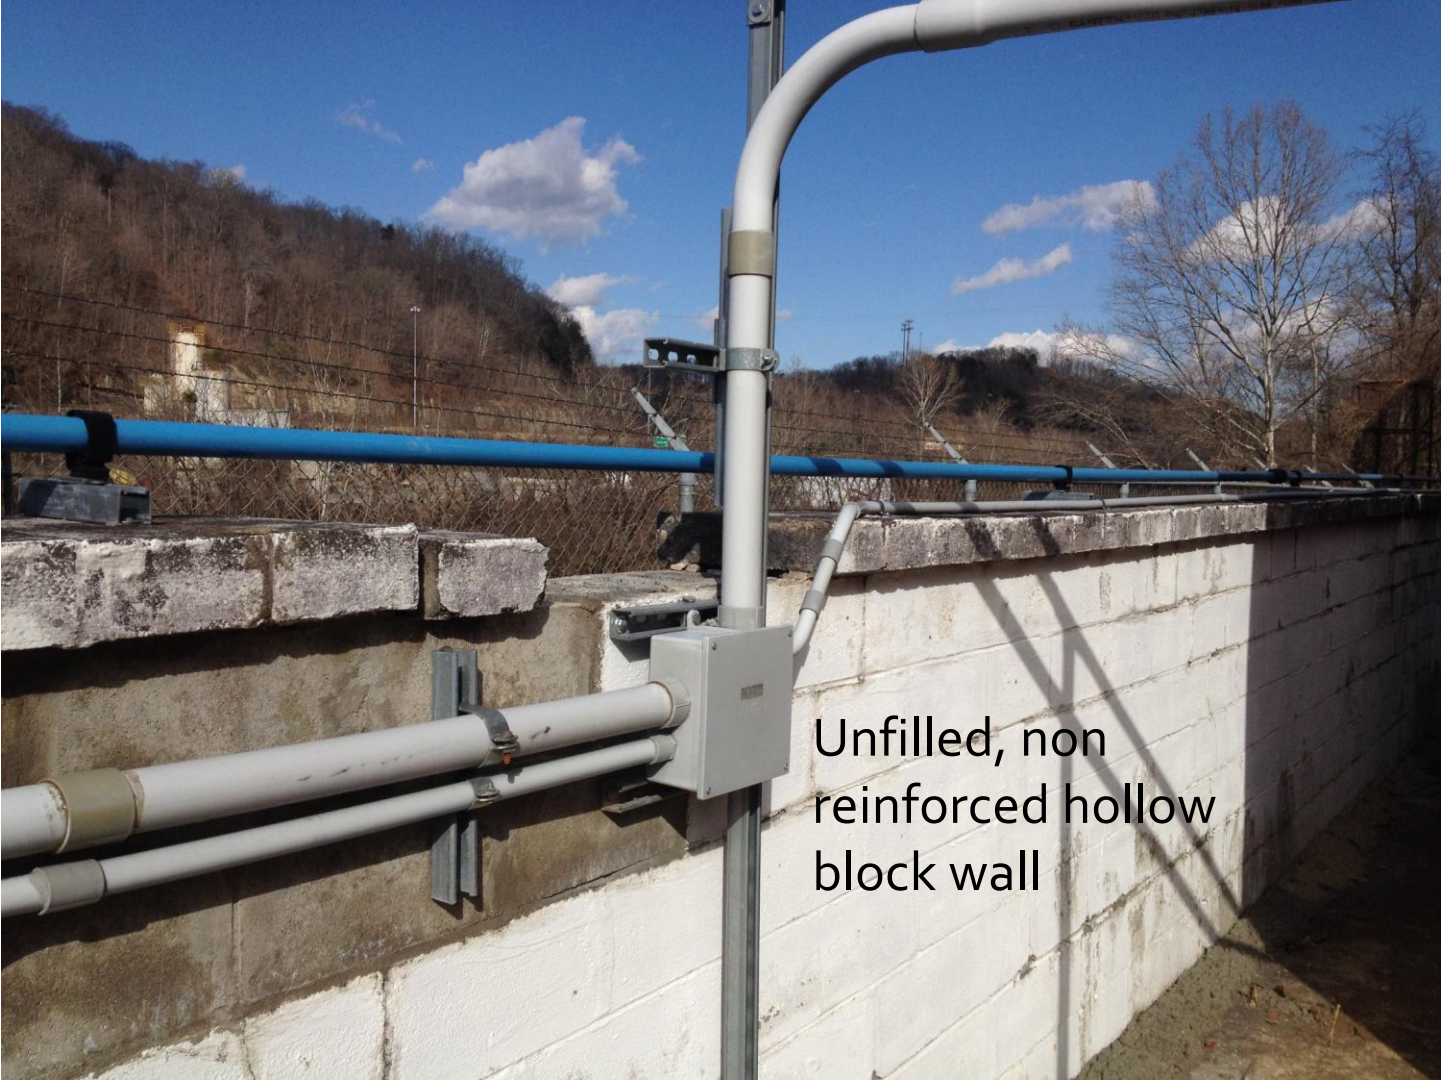
Unfilled, non
reinforced hollow
block wall

- What is the purpose of secondary containment?
- Did Freedom know the purpose?
- As a new employee would you ask your boss why the hole is there? Would you exercise stop work authority if your company allowed it?
- What would you do?

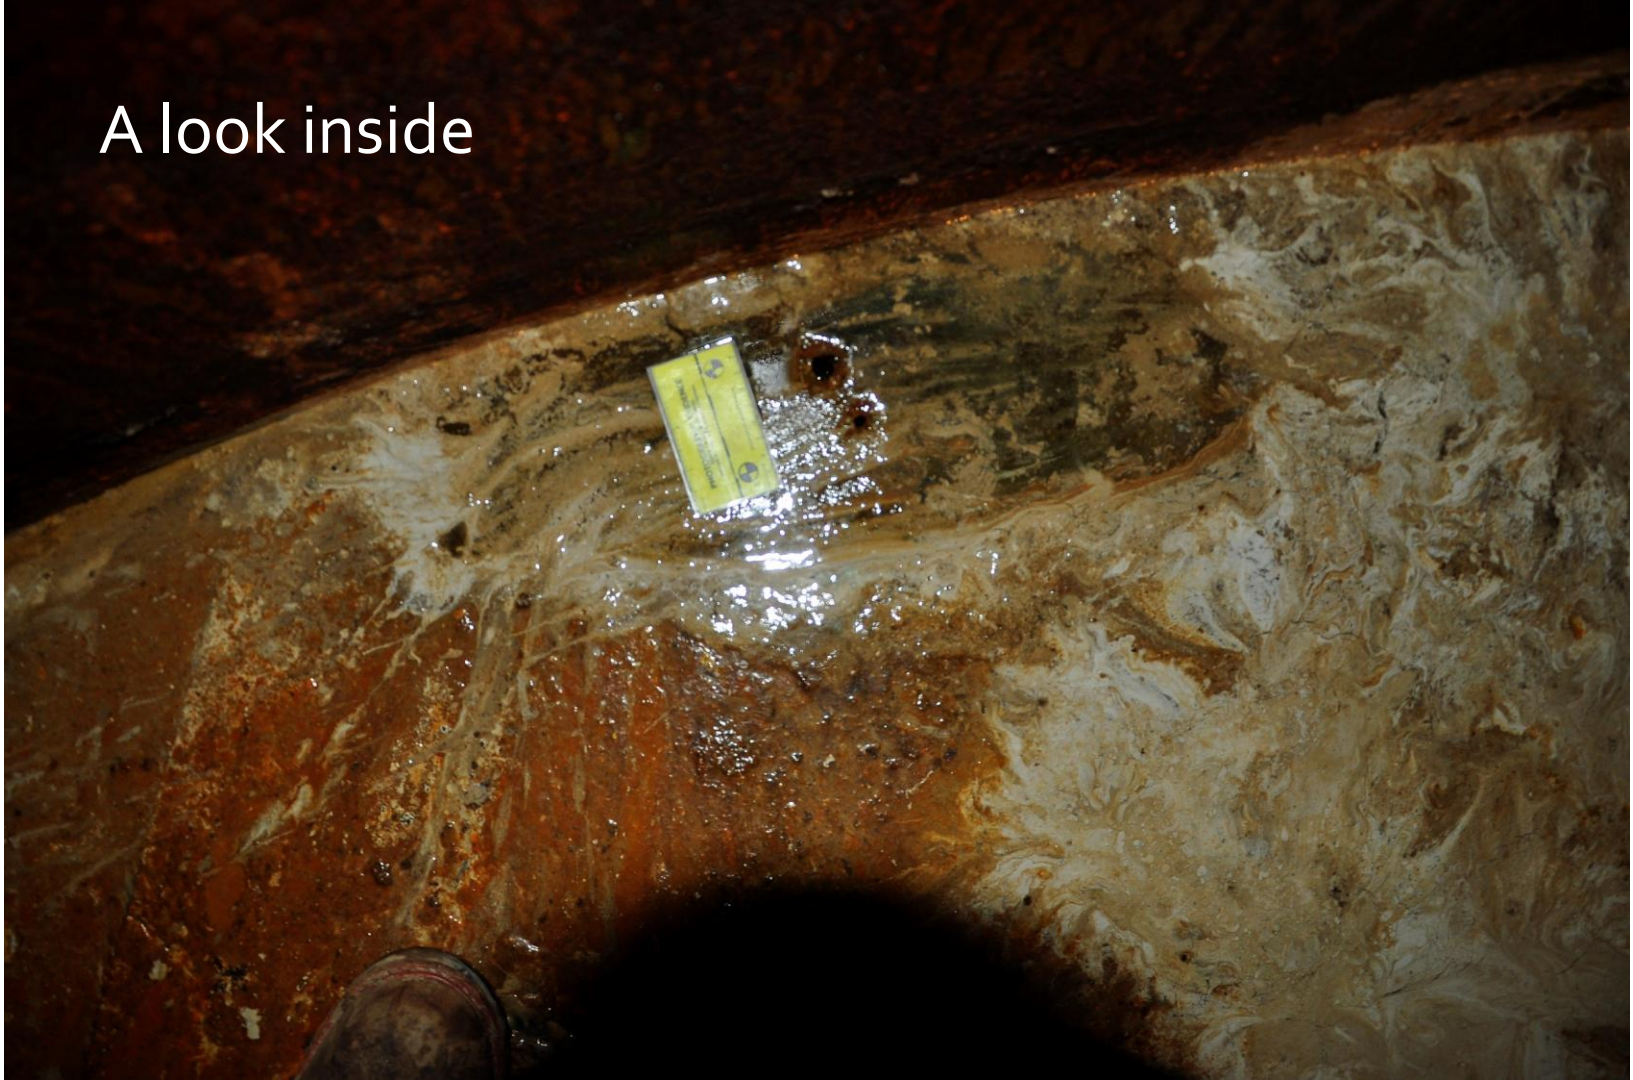
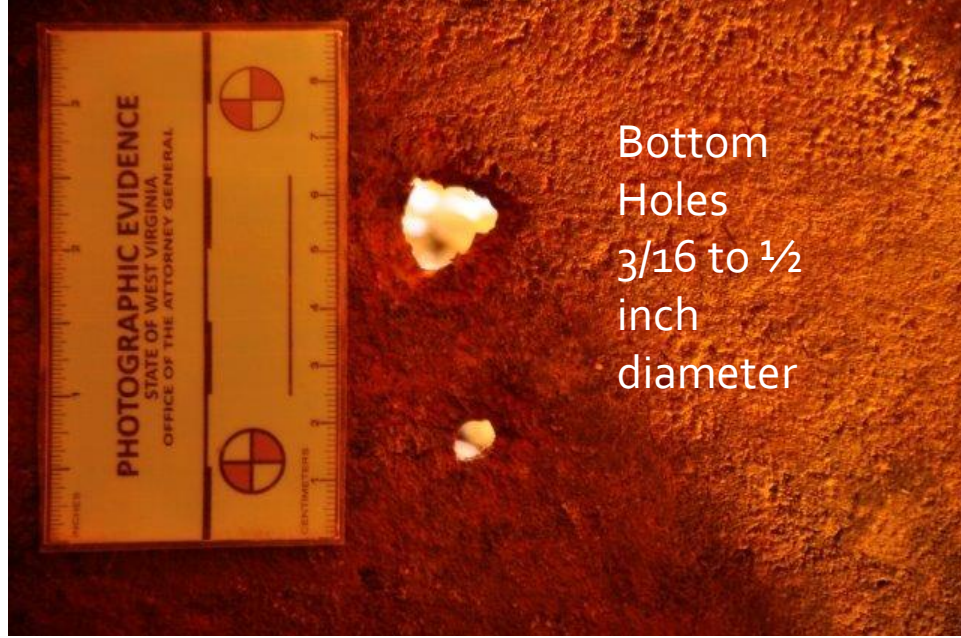
A look inside

Bottom
Holes
3/16 to 1/2
inch
diameter

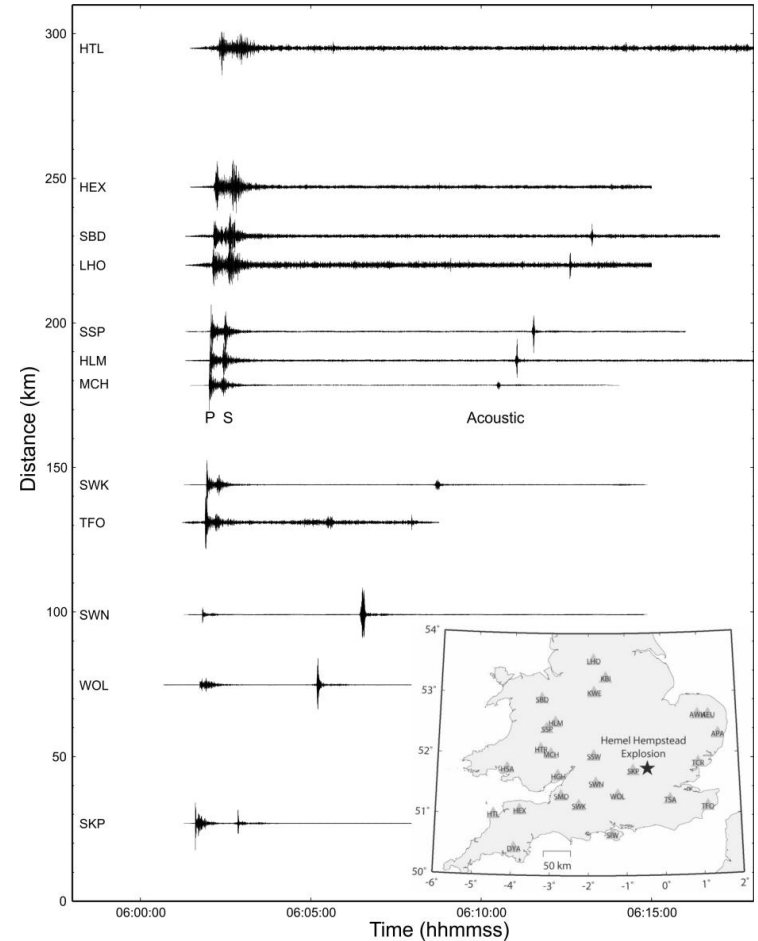
Seismograms

- The explosion was detected on seismograph stations in the UK and the Netherlands
- Largest explosion in peacetime Europe
- Rough estimate 29.5 tons TNT equivalent

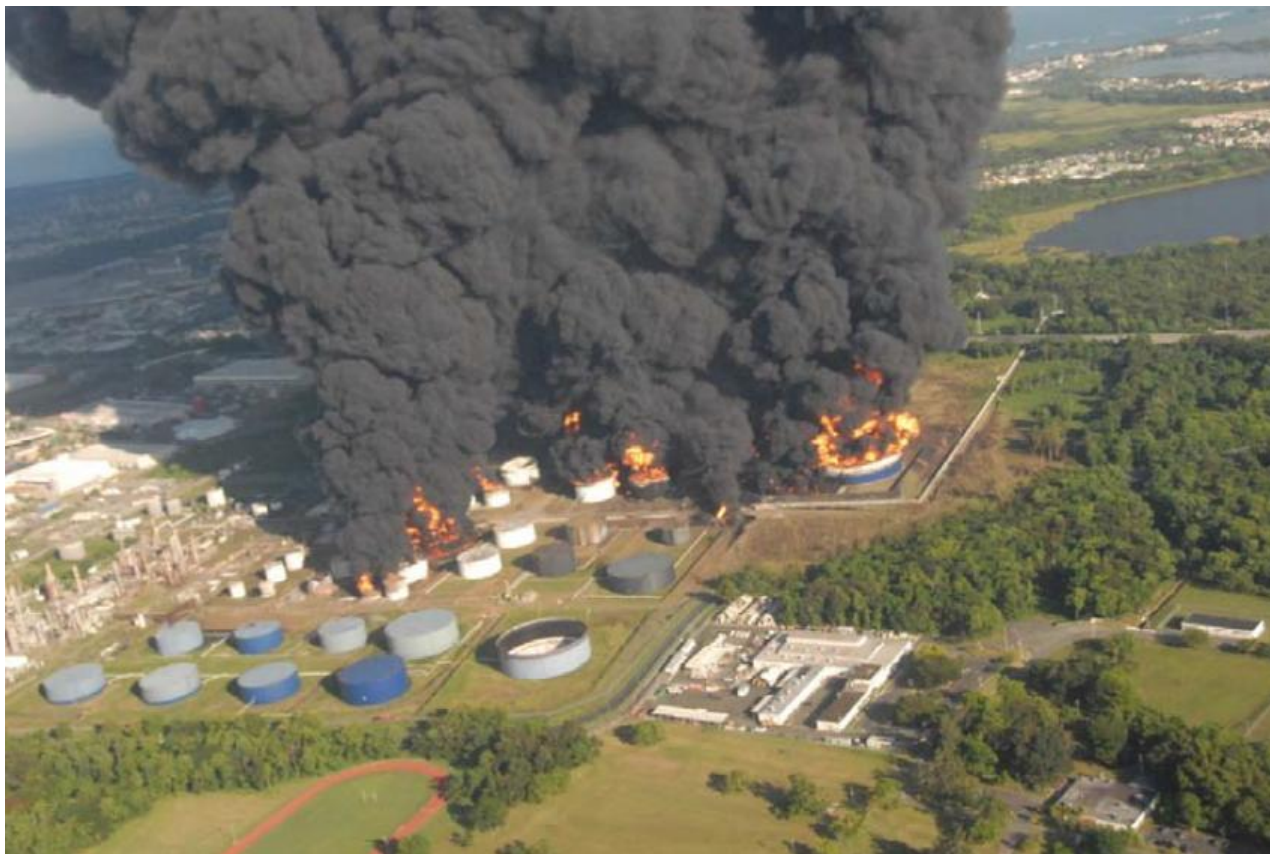
One operator at dock while another monitoring at terminal. At 10 pm T411 reached max level and T409 was opened to the 7000 gpm flow. Operator estimated T409 filled at 1am. At 11 pm operator confirmed from the side gauge that T411 would be filled at 1am. But it started to overflow between 11pm and midnight.

Overflow went on for 26 minutes dumping about 200,000 gallons of gasoline on the ground before the VCE

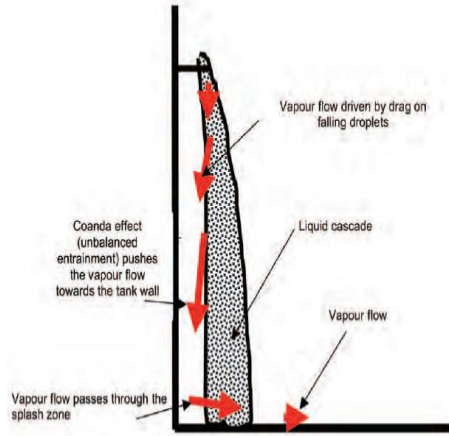
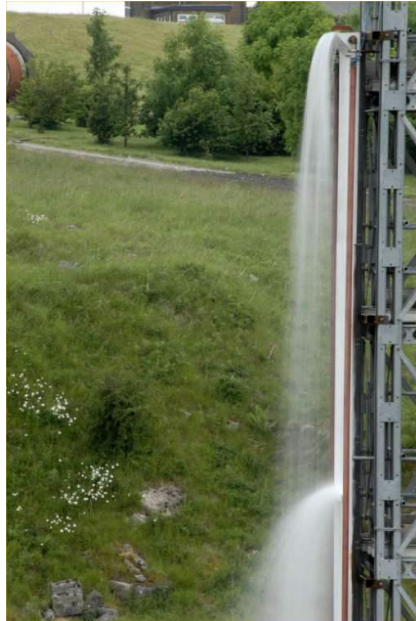
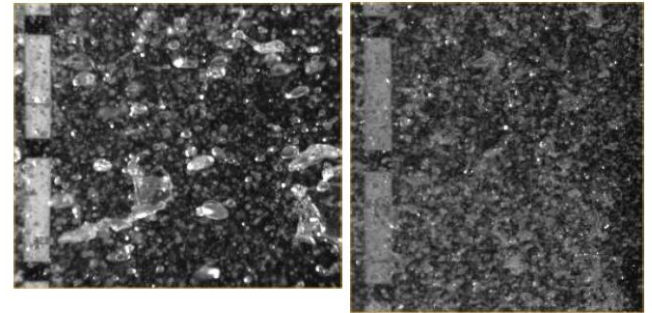
Figure 14b: Comparison between cascade droplet structure in water (left) and decene (right) in similar conditions

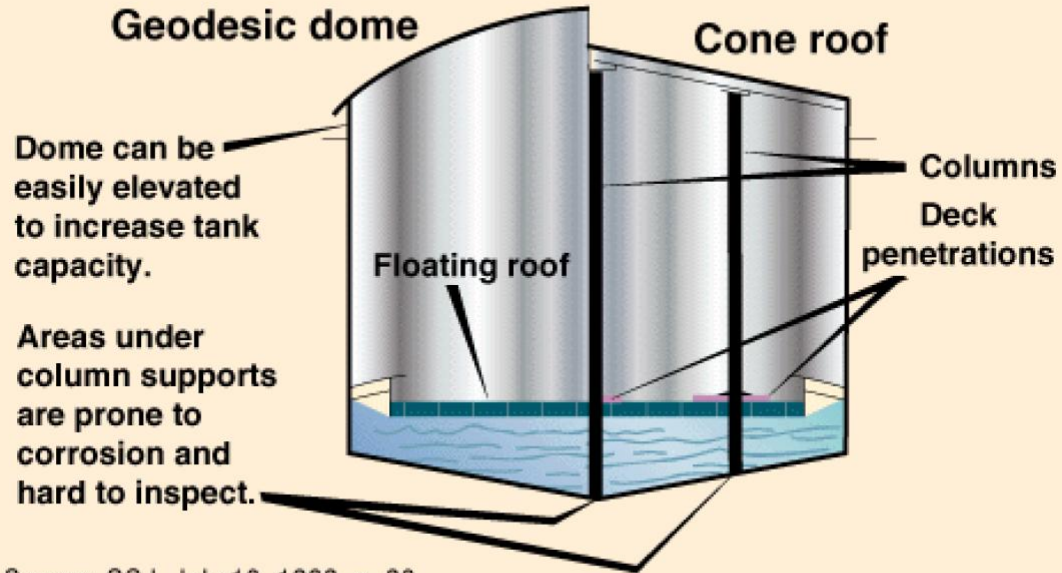
Figure 4 Contrast between geodesic and cone roofs

GEODESIC DOME VS. CONE ROOF

Source: OGJ, July 10, 1989, p. 90.

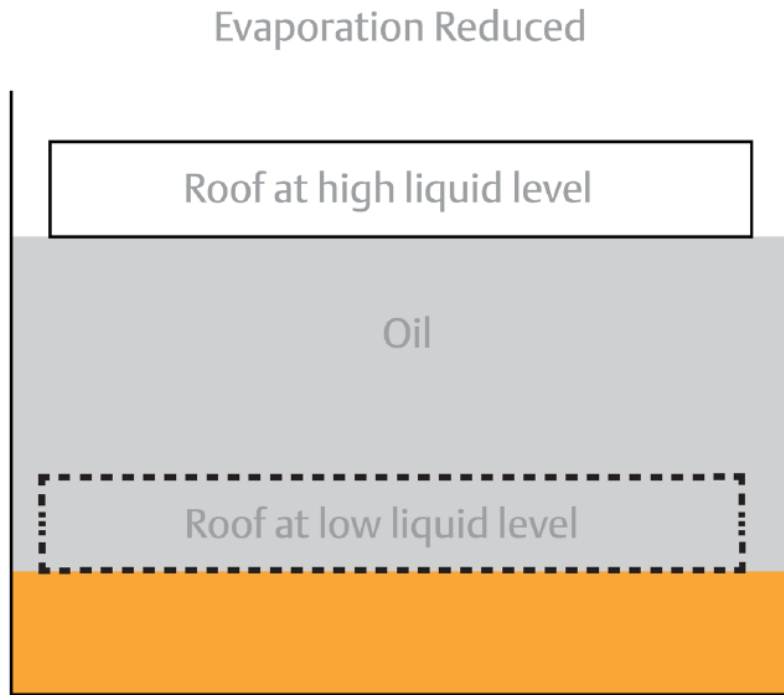
Figure 1 Conceptual diagram of floating roof tank

Floating Roof Tanks in Petroleum Storage

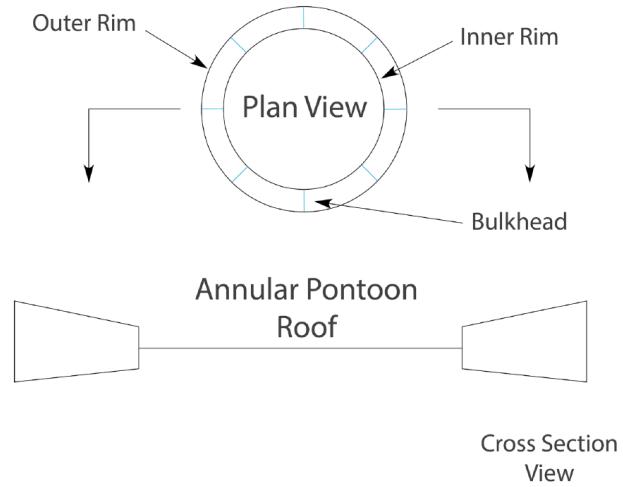
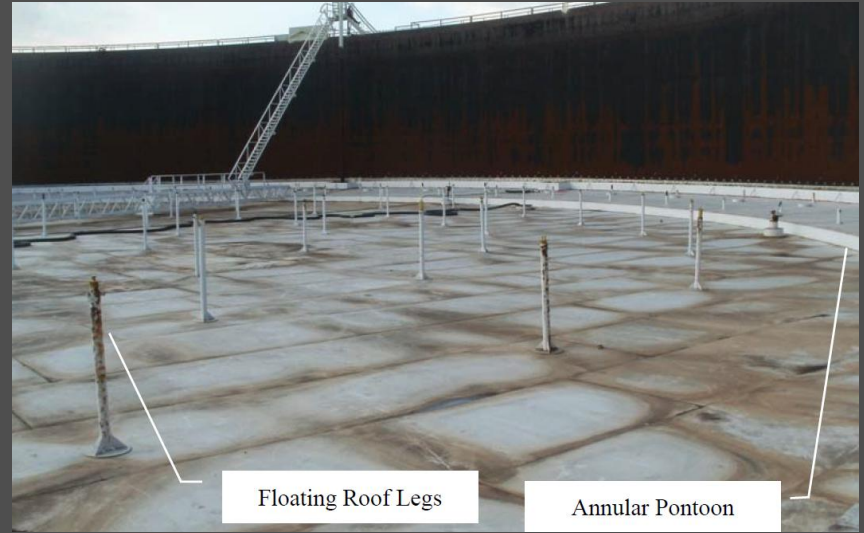
Figure 5 Schematic of an APFR

Schematic of an APFR

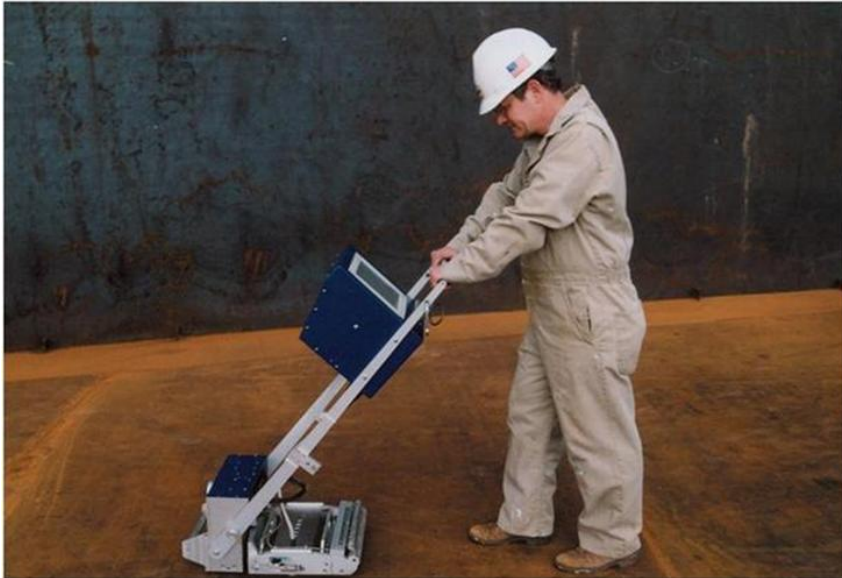
Tank Bottom Inspection

- Types
 - Top/bottomside corrosion
 - Uniform, general/localized, pitting
- Causes
 - Product, water bottoms, sediment
 - Sand pad contaminants
 - Microbes
- Magnetic Flux Leakage Examination
 - Qualification per Annex G
- Critical zone
- Uniqueness of tank bottoms

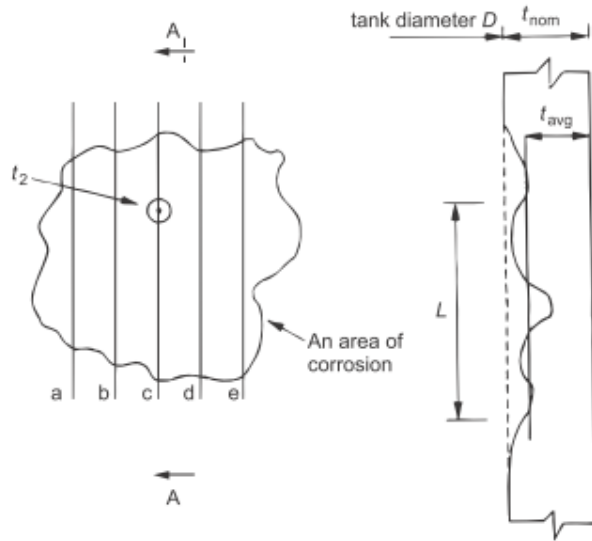
Locally Thin Area

$$L = 3.7\sqrt{Dt_2} \leq 40$$

$$t_1 \geq t_{min}$$

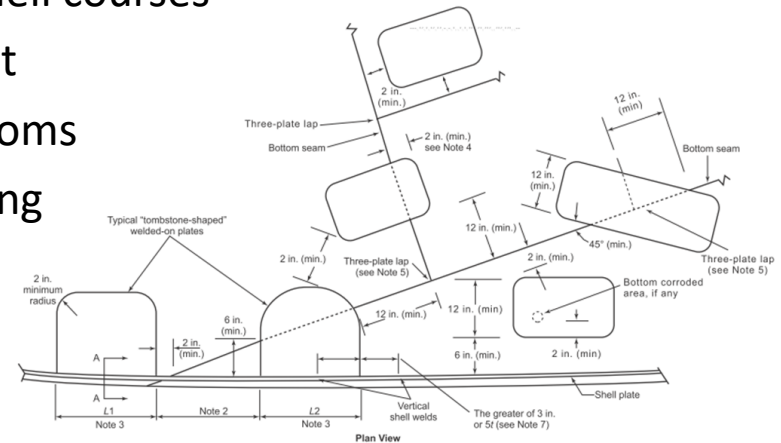
Repairs and Alteration

- API 650 equivalence
- New materials per API 650
- Repair vs. alteration
- As-built standard
- Reconstruction
 - Design
 - Methods
 - Welding
 - Inspections
 - Tolerances
- Repairs
 - Patches
 - Nozzles
 - Adding shell courses
 - Doorsheet
 - New bottoms
 - Hot tapping

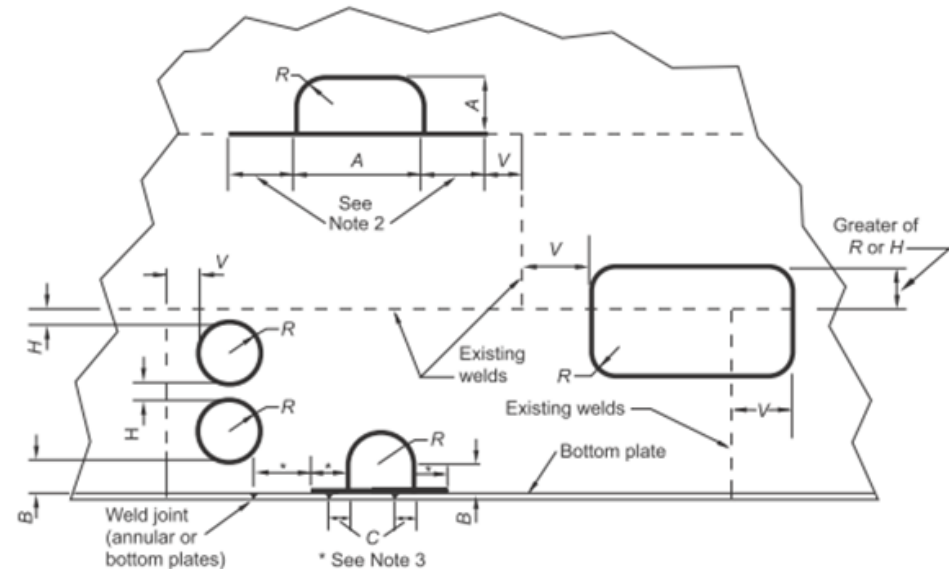
Major Repairs and Hydrostatic Testing

- Installing a shell penetration larger than NPS 12 beneath the design liquid level
- Removing and replacing or adding a shell plate beneath the design liquid level where the longest dimension of the replacement plate exceeds 12 in.

- Installing a bottom penetration within 12 in. of the shell
- Installing a complete new bottom. Installing a portion of a new bottom as described in API 653 12.3.3.3 is not a major repair.

- Removing or replacing annular plate ring material where the longest dimension of the replacement plate exceeds 12 in.;
- Complete or partial (more than one-half of the weld thickness) removal and replacement of more than 12 in. of vertical weld joining shell plates or radial weld joining the annular plate ring;

- Removing and replacing part of the weld attaching the shell to the bottom, or to the annular plate, exceeding 50% of the API 650 section area;
- Jacking a tank shell, except carefully considered minor jacking.

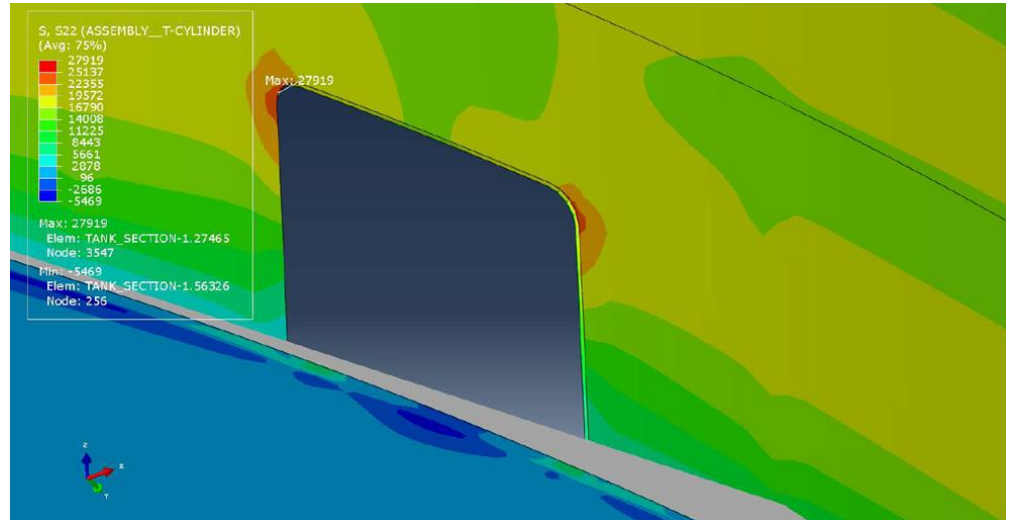
Hydrostatic Test Exemption

- Improved materials, welding, and examinations
- Proportionality
- Fitness-for-service API 579

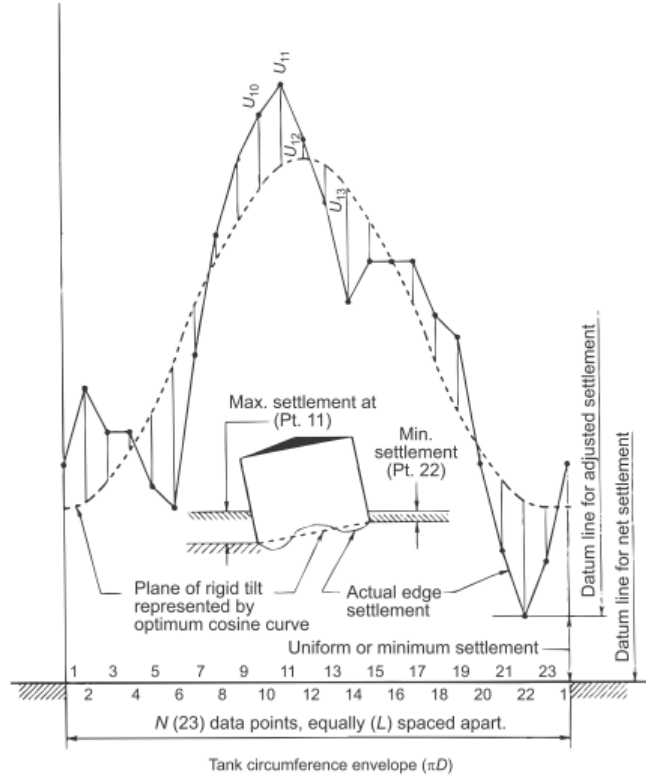
Cosine Curve

- Uniform planar
- Tilt planar
- Differential
- Global dishing
- Local bulges or bowls
- Edge
- Ridge

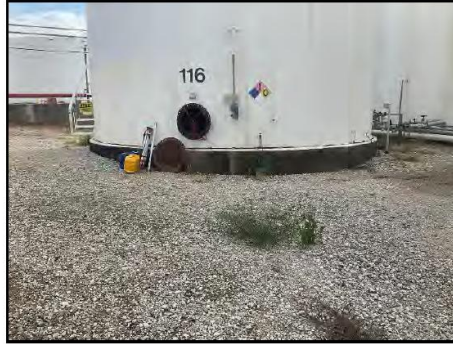
001 Grade Surrounding Tank Foundation

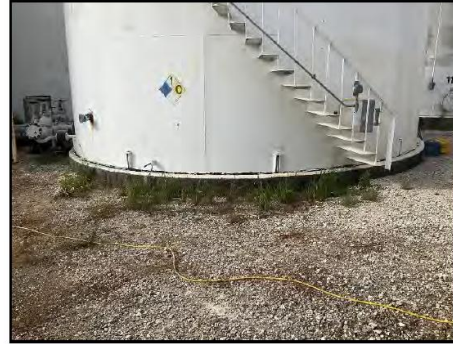
002 Grade Surrounding Tank Foundation

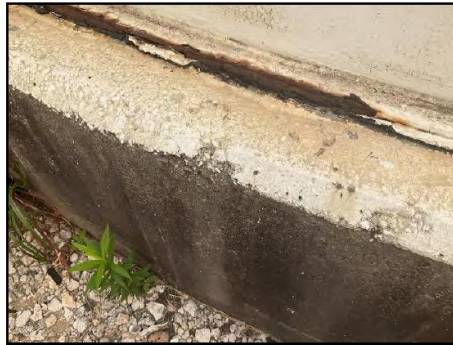
003 Spalling on Ringwall

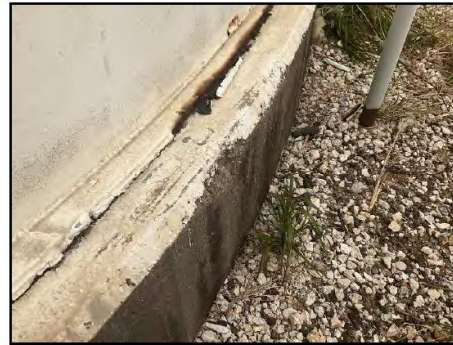
004 Spalling on Ringwall

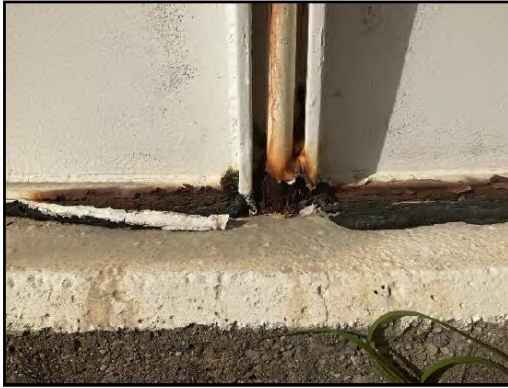
031 Active Corrosion on Anchor Chair X

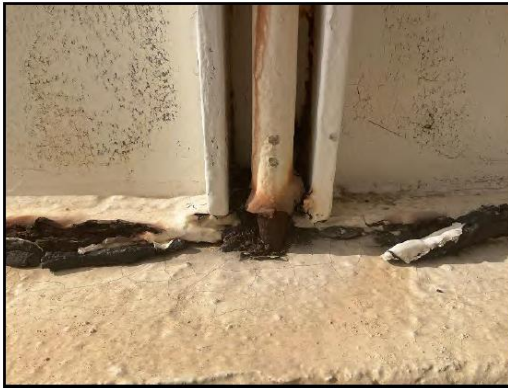
033 Active Corrosion on Anchor Chair Z
