System-based CalARP Inspection: TU-A2 March 25, 2025 Alvin Lal — Stanislaus County CUPA Manager Tommy Rios — Process Safety Engineer, Resource Compliance

- Introduction
- Knowledge Survey
- Conversation, Dialogue
- Prevention Programs (2,3)
- Ammonia Engine Rm. Equip. Inspection

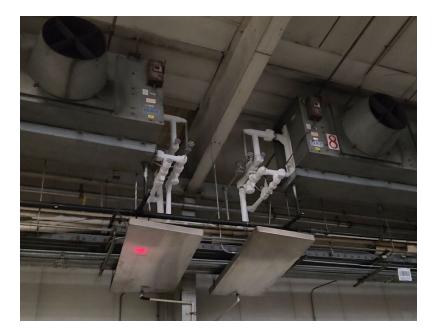
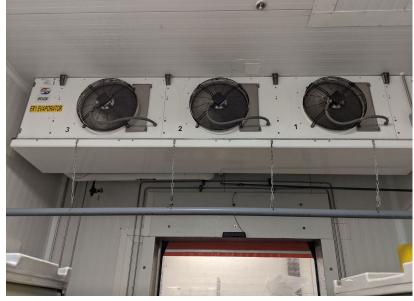
- Drain pans/catch cans beneath the iced piping
- The drain pans allow water to be drained into a drain
- Prevents water from pooling below the evaporators
- No slip hazard

- The evaporator is protected by a bumper bar
- Early indicator before hitting the evaporator

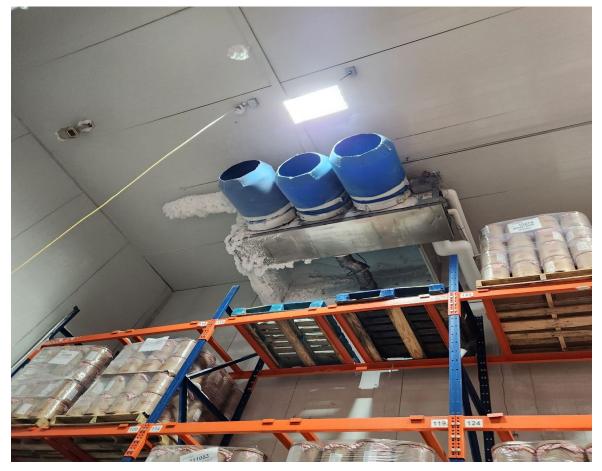
Problems

- •The accumulation of ice on the evaporator
 - Added weight of the ice increases the load on the evaporator supports
 - Ice acts as an insulator, which causes the evaporator to run less efficiently
 - Ice buildup can interfere with the fan blades (dangerous)
- Accumulation of ice on the ceiling
 - Ice on the ceiling indicates that there is a vapor barrier breach in the ceiling/roof

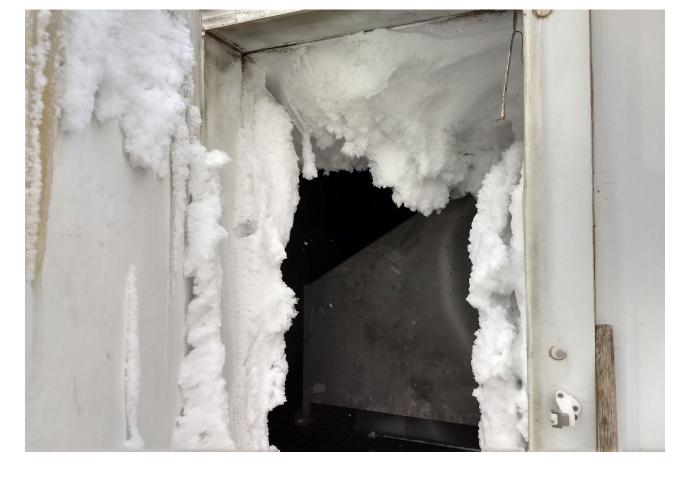
Ice buildup on a penthouse door

- The ice prevents the door from closing
- Sometimes results in unsafe ways of forcing a door closed
- Defeats panic hardware being operated from inside the refrigerated space
- Ice can restrict access from/to the penthouse
- Major source of heat loss

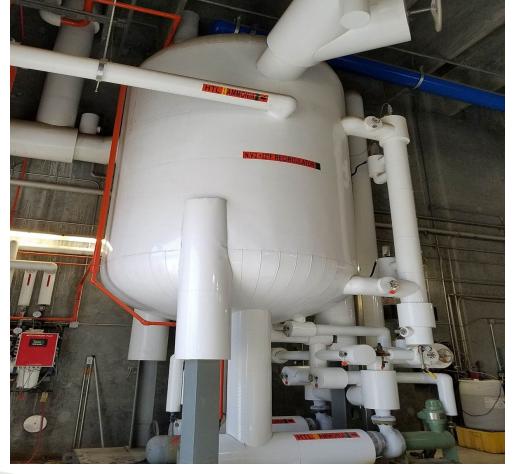
- •Vessel and piping are clearly labeled
- •No ice on the insulation
- •Dead-man valve at the drain point

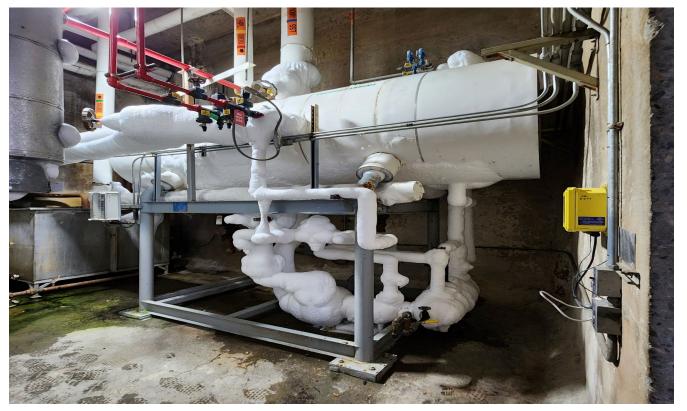
- •Ice indicates that the insulation on the vessel has failed
- •Ice on the piping and valves can prevent the valves from being manipulated/operated
- •lce prevents piping from being inspected (insulation or corrosion)

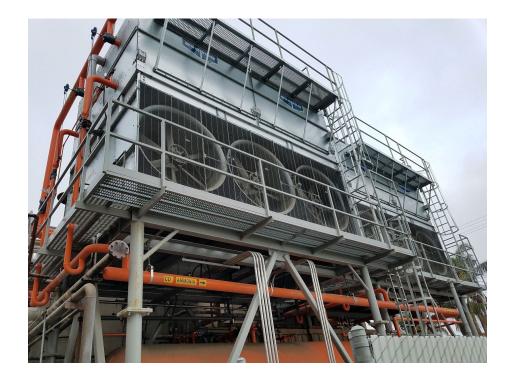
- Piping is painted
- •Permanent access to the mist eliminators and fans
- •No indication of water leaks

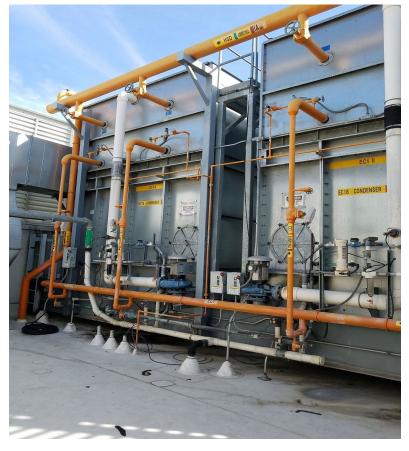
- •Not labeled
- •Piping is corroded
- •Heavy water stains are indicative of water leaking
- •Man door appears not to be sealed

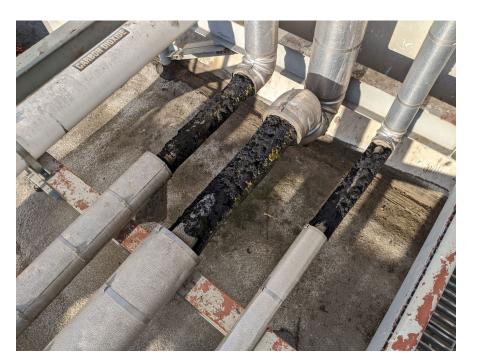
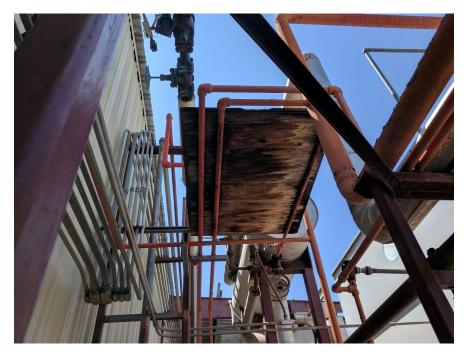
- •Flexible stainless-steel piping was used and the insulation installed was not approved for use with ammonia
- •Poor insulation traps moisture as opposed to keeping it out
- •The pipes are being used as a platform. Ammonia pipes should not be used to support external loads

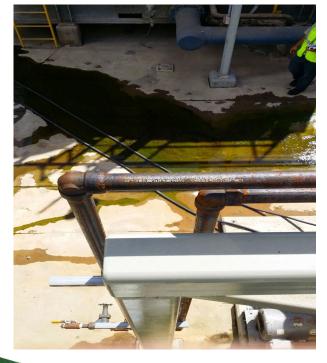
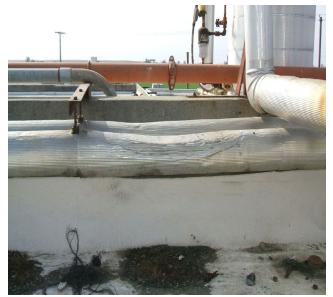
- •Uninsulated pipes not protected against corrosion
- •Pipes are not labeled
- •The insulation is crushed because people stepped/sat on it while crossing this barrier
- •The pipe labels are faded

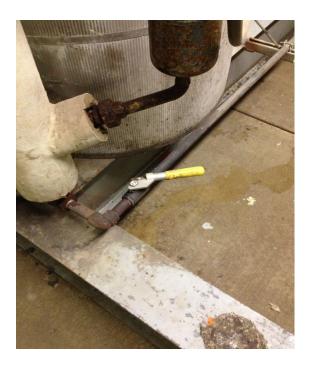
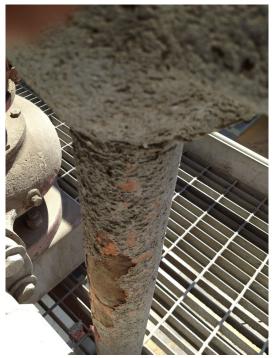
King valve label faded Receiver tank paint chipping

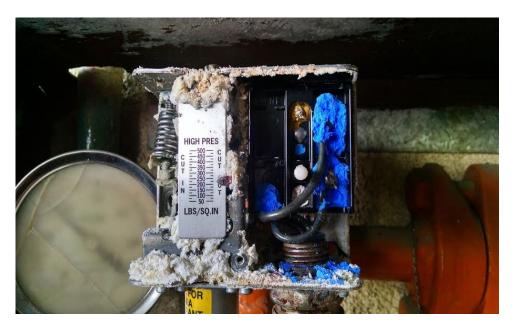
- Corroded, Not labeled
- Compressor safety cutout deteriorated

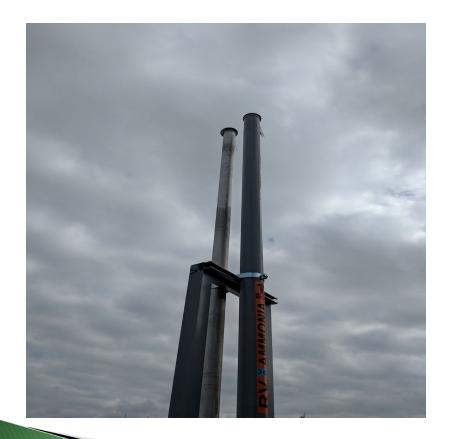
•Relief piping is more than 7.25' above the roof

Piping is labeled

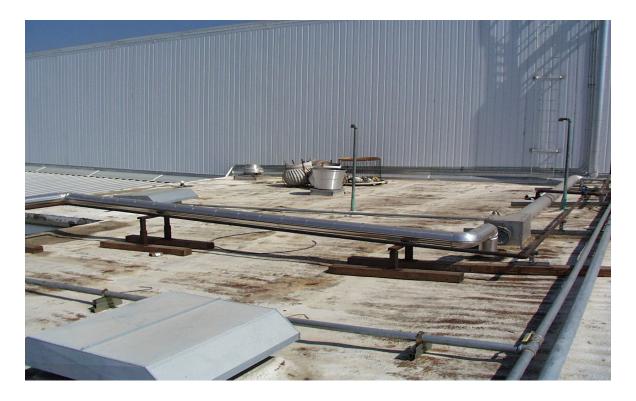
- •Relief piping terminates less than 7.25' above the roof
- •Relief piping is not labeled
